## SAFETY RECOMMENDATION No: 27/2013

<b>No of Safety Investigation Report:</b>	05/2013: Death of visitor on board Ro-Pax "NISOS RODOS" <i>(See the full Report <a href="#">here.</a>)</i>
---	---

#### **Death of visitor on board Ro-Pax**

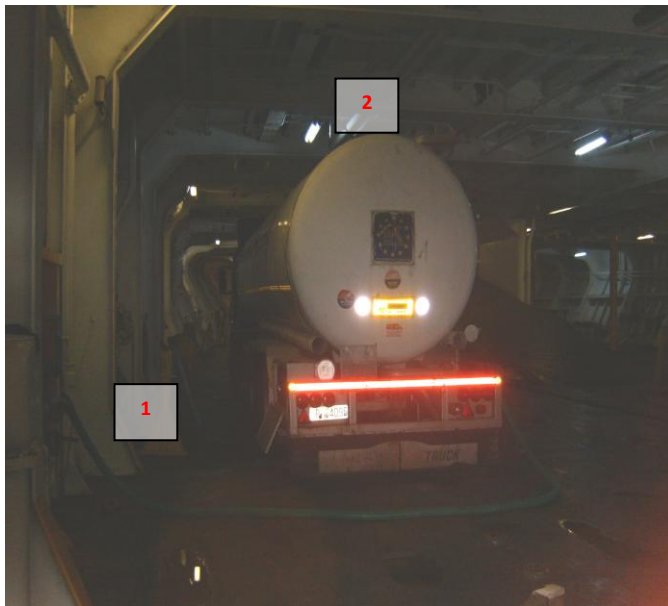
**Picture 1:** The tank truck parked near the water inlet valve, inside the garage of the Ro-Pax “NISSOS RODOS”. The water pipe, connected to the ship’s fresh water inlet valve is noticed. The position of the Boatswain (1) and the position of the driver (2) during the development of the accident have been marked.

The procedures for the connection of the lines and the water supply were followed, which included the opening of the tank truck vents. The ship’s Boatswain was at the connection point of the ship’s network with the hose of the tank truck and the truck driver had climbed onto the top of the tank of the vehicle to open the vents.

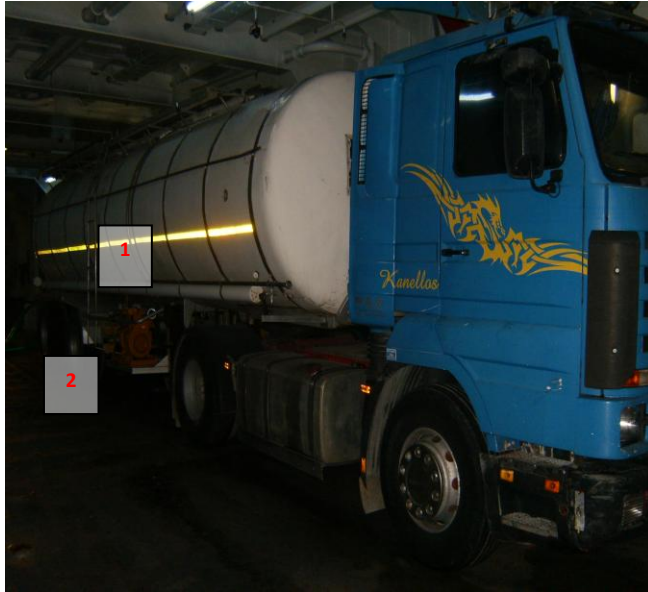
At that point, the co-driver of the vehicle, who, based on the collected evidence, had climbed or had attempted to climb to the truck’s tank, slipped and fell to the deck resulting to the injury of his head and neck.

**Picture 2:** The tank truck parked at the point of the water supply, in the garage of the Ro-Pax "NISSOS RODOS". The ladder on the right side of the tank (1) and the place where the injured was found (2) have been marked.

According to the findings of the forensic report, the loss of life of the visitor of the Ro-Pax occurred "as a result of head, neck and chest injuries, compatible with a fall" and therefore it was the result of falling off the tank truck's ladder.

It is noted that there had been no risk assessment for the ship's water supply process, while the co-driver of the tank truck, who was in the cabin of the truck, entered in the area of the main garage as a visitor, not having been checked by the ship's personnel and not having been accompanied by a crew member, as provided in the Safety Management Manual of the ship and the ship's Security System.

The regular briefing towards the crew of the ship concerning the regulations of the SMM and the SSP and in particular the control of entry of visitors with emphasis in cases of conducting works or services to the ship and the performance of internal controls for compliance with the relevant provisions.
