SAFETY RECOMMENDATION No: 28/2014

03/2014: Explosion on board M/V "NAKHODKA"
(See the full Report [here.](#))

Name of vessel: NAKHODKA
Type of vessel: General Cargo
Year of built: 1978
Flag: Russian

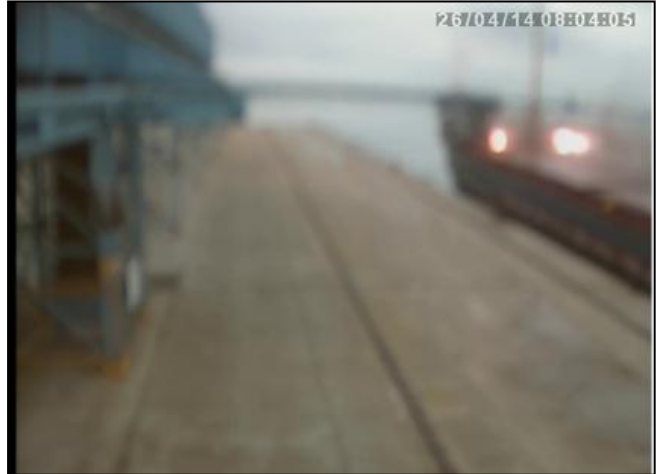
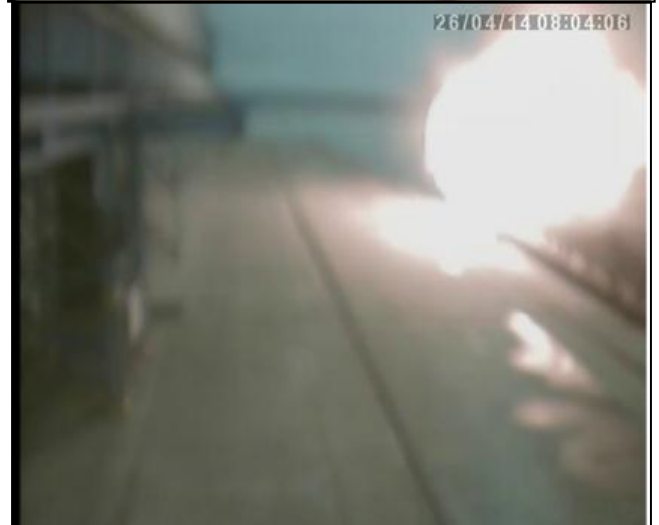
Photos from the explosion

The vessel sustained damages due to the explosion and the fire, in the forecastle, such as distortion of bulkheads and burning of equipment.

The casualty was caused by the ignition of propane gas that had leaked from the storage bottle and accumulated at the lower levels of the Boatswain's Store. The ignition source could not be identified; however spark from unprotected lighting equipment found at the area or spark caused by static electricity or friction/impact of metal tools or other metallic equipment were highlighted as possible sources.
