SAFETY RECOMMENDATION No: 29/2015

05/2015: Fire onboard HSC Ro-Ro Passenger Ship HIGH SPEED 5, Flag Greece, IMO 9329095 and death of her Chief Electrician on 23rd March 2015 at Keratsini, Greece.

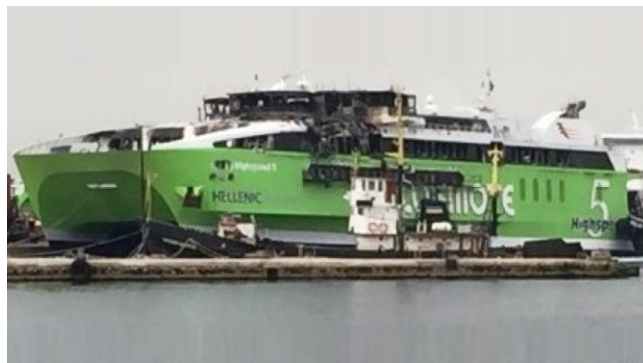
HIGHSPEED 5 sustained major damages, since all her accommodation compartments above the Upper Deck were completely destroyed. Her navigation bridge and all equipment were also destroyed.

Figures 2 & 3: General side views of the ship showing her extended damage.

1. The fire may have been caused due to the high temperature of the "Business" salon's top plating where welding works were being performed and the combustion of the adjacent insulation placed below it, which had not been removed, as would be appropriate.
2. The Master and the competent crew of HIGHSPEED 5 had not been informed regarding the execution of hot works above the "Business" salon on the day of the accident.
3. The crew's training regarding the procedure of entering an enclosed space had not been sufficient.
4. The Contractor of the conversion had not activated procedures regarding the application of safety measures according to the Safety Technician's recommendations.
5. The fire detection system was not activated due to the fact that there were no sensors inside the space between the top plating and the ceiling of the passengers' salon, where the fire was initially developed.

1. Actions should be taken by the ship's Managing Company to include in its Safety Management System procedures such as:
 - the use of portable VHF devices by key personnel, when the ship is not in operation,

- the appointment of substitute crew members for emergency procedures when the ship is not in operation,
 - the appointment of a person designated exclusively for the supervision of the works regarding the safety procedures,

- the provision of a person's constant presence in the navigation bridge for the supervision of the fire detection and fire extinguishing systems.
2. Actions should be taken by the ship's Managing Company to examine the possibility of installing fire detectors inside the spaces covered by the accommodation spaces' ceilings.
