SAFETY RECOMMENDATION No: 30/2014

04/2014: Impact of RoPax EUROPALINK on Peristerai Islet shoal reef.

Impact of RoPax EUROPALINK on Peristerai Islet shoal reef, Italian Flag, IMO 9319454

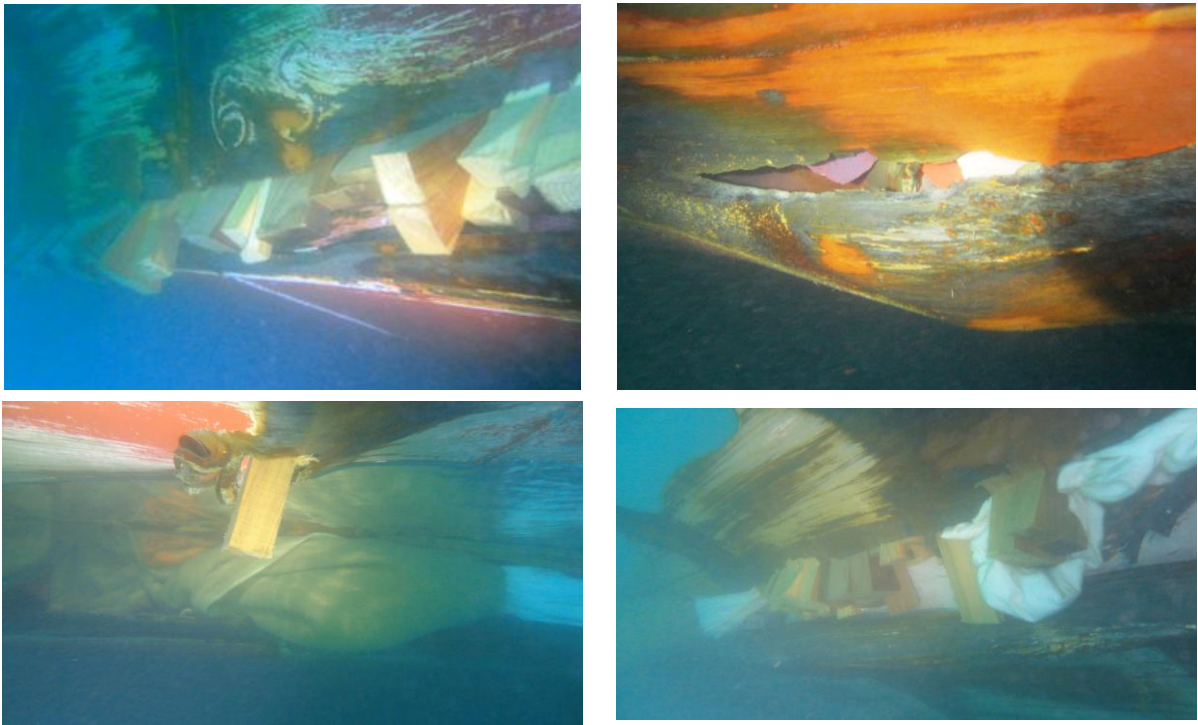
EUROPALINK severed extended hull damages (deformations and cracks and intends), as follows:

- port side from fr. 115 to fr. 204 (62,3 m)
- stbd side from fr. 82 to fr. 154 (50,4 m).

Several Void Spaces were also breached and engine room compartments were flooded. Damages to critical equipment such as her Main Engines, boilers, motors, pumps, electronic components, etc were reported.

Photos from the bottom damage and counter flooding underwater operations carried out by the local divers' team

It was decided to shift her on the same dock and moor her alongside with her port side so as to unload trucks and vehicles through the stern ramp. The shifting operation was completed at approximately 1238. Following, the stern ramp was opened and the discharging operation of the garage spaces commenced while the team of two divers started chocking wooden wedges and other materials inside the breached bottom platings.

Europolink underwent temporary repairs and following an inspection by her Class, on 31 October 2014 she sailed under towage to Yalova shipyard in Turkey for drydocking.
