SAFETY RECOMMENDATION No: 30/2015

05/2015: Fire onboard HSC Ro-Ro Passenger Ship HIGHSPEED 5, Flag Greece, IMO 9329095 and death of her Chief Electrician on 23rd March 2015 at Keratsini, Greece.

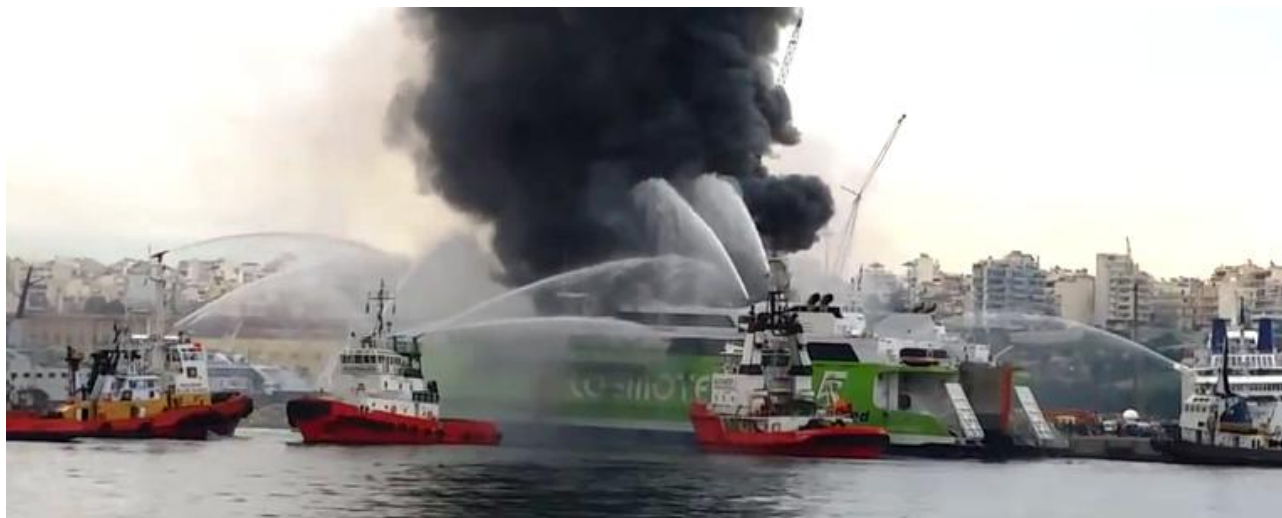
Figure 1: The deployment of the firefighting boats was imminent.

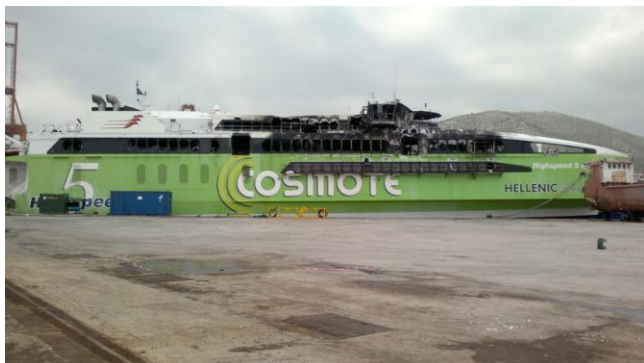
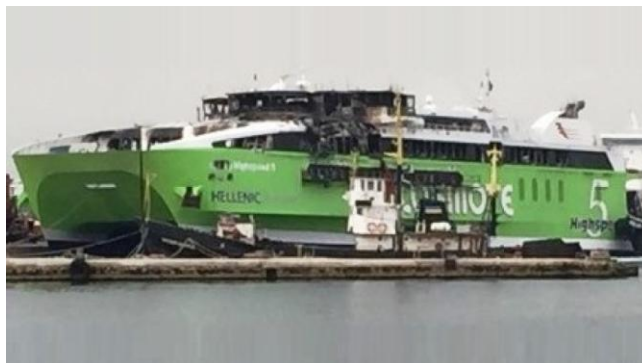
HIGHSPEED 5 sustained major damages, since all her accommodation compartments above the Upper Deck were completely destroyed. Her navigation bridge and all equipment were also destroyed.

Figures 2 & 3: General side views of the ship showing her extended damage.

1. The fire may have been caused due to the high temperature of the "Business" salon's top plating where welding works were being performed and the combustion of the adjacent insulation placed below it, which had not been removed, as would be appropriate.
2. The Master and the competent crew of HIGHSPEED 5 had not been informed regarding the execution of hot works above the "Business" salon on the day of the accident.
3. The crew's training regarding the procedure of entering an enclosed space had not been sufficient.
4. The Contractor of the conversion had not activated procedures regarding the application of safety measures according to the Safety Technician's recommendations.
5. The fire detection system was not activated due to the fact that there were no sensors inside the space between the top plating and the ceiling of the passengers' salon, where the fire was initially developed.

Amendment of the SMS in view of providing substitutes for the crew members with critical duties for emergency procedures for the periods when the ship is not in normal operation and works are in progress.

1. Actions should be taken by the ship's Managing Company to include in its Safety Management System procedures such as:
 - the use of portable VHF devices by key personnel, when the ship is not in operation,

- the appointment of substitute crew members for emergency procedures when the ship is not in operation,
 - the appointment of a person designated exclusively for the supervision of the works regarding the safety procedures,

- the provision of a person's constant presence in the navigation bridge for the supervision of the fire detection and fire extinguishing systems.
2. Actions should be taken by the ship's Managing Company to examine the possibility of installing fire detectors inside the spaces covered by the accommodation spaces' ceilings.
