## **SAFETY RECOMMENDATION No: 31/2014**

04/2014: Impact of RoPax EUROPALINK on Peristerai Islet shoal reef.

### **Impact of RoPax EUROPALINK on Peristerai Islet shoal reef, Italian Flag, IMO 9319454**

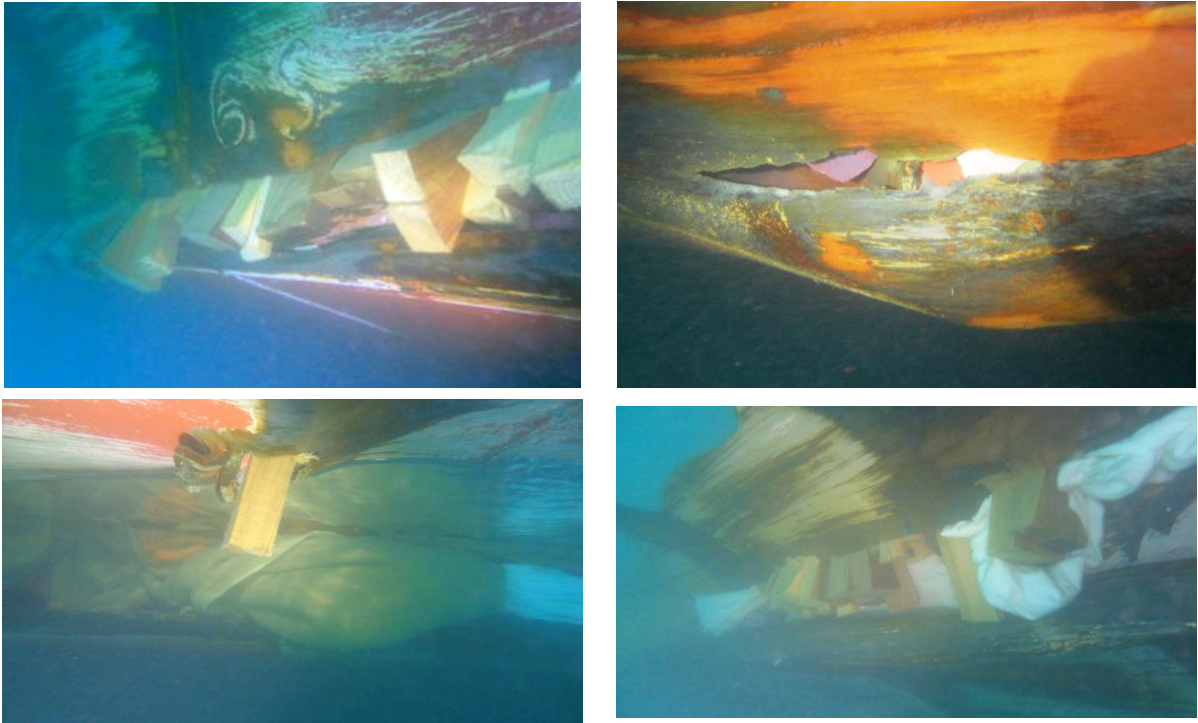
EUROPALINK severed extended hull damages (deformations and cracks and intends), as follows:

- port side from fr. 115 to fr. 204 (62,3 m)
- stbd side from fr. 82 to fr. 154 (50,4 m).

Several Void Spaces were also breached and engine room compartments were flooded. Damages to critical equipment such as her Main Engines, boilers, motors, pumps, electronic components, etc were reported.

Photos from the bottom damage and counter flooding underwater operations carried out by the local divers' team

It was decided to shift her on the same dock and moor her alongside with her port side so as to unload trucks and vehicles through the stern ramp. The shifting operation was completed at approximately 1238. Following, the stern ramp was opened and the discharging operation of the garage spaces commenced while the team of two divers started chocking wooden wedges and other materials inside the breached bottom platings.

Europolink underwent temporary repairs and following an inspection by her Class, on 31 October 2014 she sailed under towage to Yalova shipyard in Turkey for drydocking.
