SAFETY RECOMMENDATION No: 32/2014

04/2014: Impact of RoPax EUROPALINK on Peristerai Islet shoal reef.

Impact of RoPax EUROPALINK on Peristerai Islet shoal reef, Italian Flag, IMO 9319454

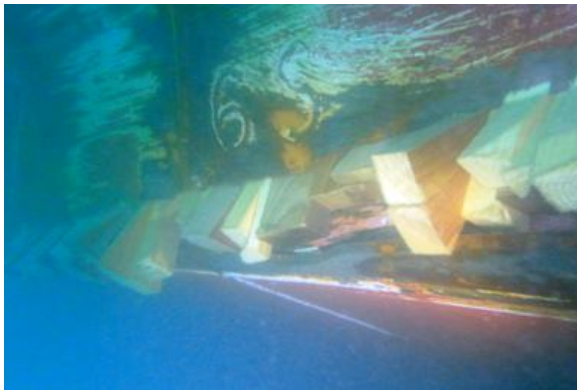
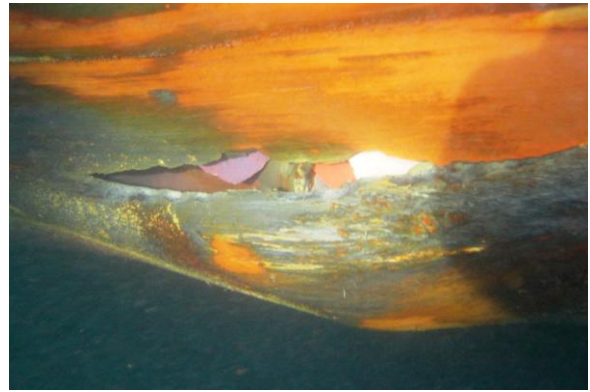
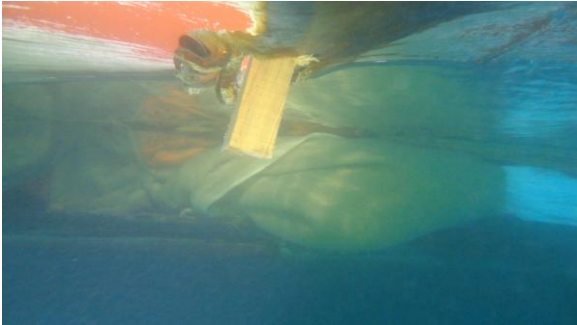
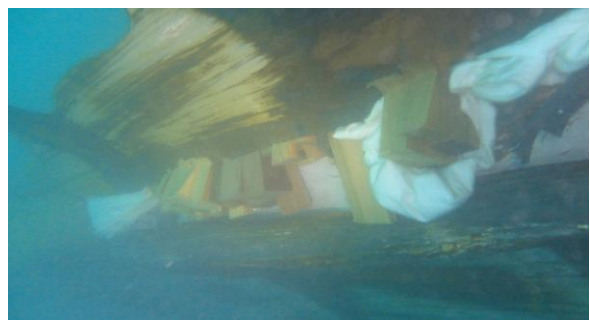
EUROPALINK severed extended hull damages (deformations and cracks and intends), as follows:

- port side from fr. 115 to fr. 204 (62,3 m)
- stbd side from fr. 82 to fr. 154 (50,4 m).

Several Void Spaces were also breached and engine room compartments were flooded. Damages to critical equipment such as her Main Engines, boilers, motors, pumps, electronic components, etc were reported.

Photos from the bottom damage and counter flooding underwater operations carried out by the local divers' team
