## SAFETY RECOMMENDATION No: 32/2015

05/2015: Fire onboard HSC Ro-Ro Passenger Ship HIGHSPEED 5, Flag Greece, IMO 9329095 and death of her Chief Electrician on 23<sup>rd</sup> March 2015 at Keratsini, Greece.

### **Fire onboard HSC Ro-Ro Passenger Ship HIGHSPEED 5, Flag Greece, IMO 9329095 and death of her Chief Electrician on 23<sup>rd</sup> March 2015 at Keratsini, Greece.**

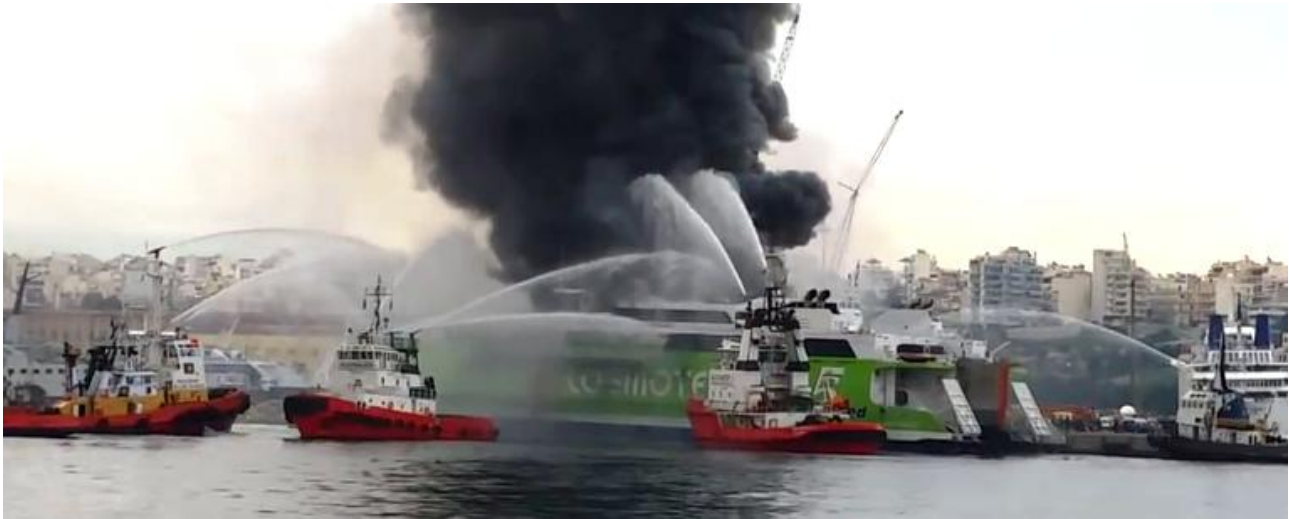
**Figure 1:** The deployment of the firefighting boats was imminent.

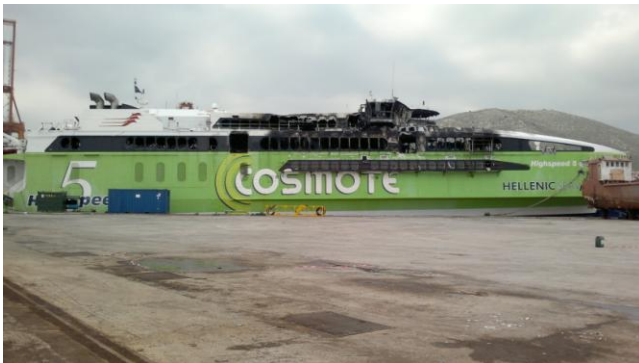
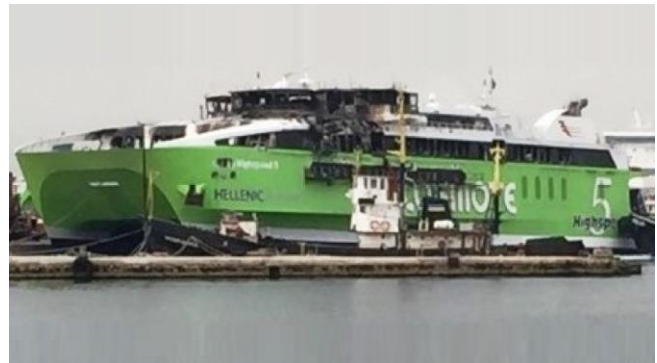
HIGHSPEED 5 sustained major damages, since all her accommodation compartments above the Upper Deck were completely destroyed. Her navigation bridge and all equipment were also destroyed.

**Figures 2 & 3:** General side views of the ship showing her extended damage.

1. The fire may have been caused due to the high temperature of the "Business" salon's top plating where welding works were being performed and the combustion of the adjacent insulation placed below it, which had not been removed, as would be appropriate.
2. The Master and the competent crew of HIGHSPEED 5 had not been informed regarding the execution of hot works above the "Business" salon on the day of the accident.
3. The crew's training regarding the procedure of entering an enclosed space had not been sufficient.
4. The Contractor of the conversion had not activated procedures regarding the application of safety measures according to the Safety Technician's recommendations.
5. The fire detection system was not activated due to the fact that there were no sensors inside the space between the top plating and the ceiling of the passengers' salon, where the fire was initially developed.

Amendment of the SMS in view of providing one crew member on the navigation bridge for the attendance of the fire indication panel and the fire fighting piping “Sprinkler” system. Also in view of providing directions regarding the function status of both systems when the bridge is unattended (Deactivation of the 2min delay of the fire indication panel and adjustment of the Sprinkler function to Automatic mode).

1. Actions should be taken by the ship's Managing Company to include in its Safety Management System procedures such as:
  - the use of portable VHF devices by key personnel, when the ship is not in operation,

- the appointment of substitute crew members for emergency procedures when the ship is not in operation,
  - the appointment of a person designated exclusively for the supervision of the works regarding the safety procedures,

- the provision of a person's constant presence in the navigation bridge for the supervision of the fire detection and fire extinguishing systems.
2. Actions should be taken by the ship's Managing Company to examine the possibility of installing fire detectors inside the spaces covered by the accommodation spaces' ceilings.
