SAFETY RECOMMENDATION No: 35/2014

04/2014: Impact of RoPax EUROPALINK on Peristerai Islet shoal reef.

Impact of RoPax EUROPALINK on Peristerai Islet shoal reef, Italian Flag, IMO 9319454

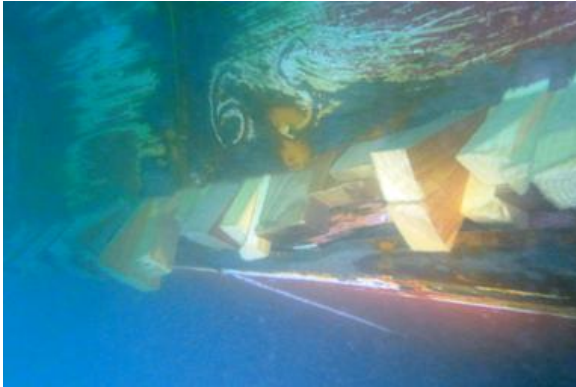
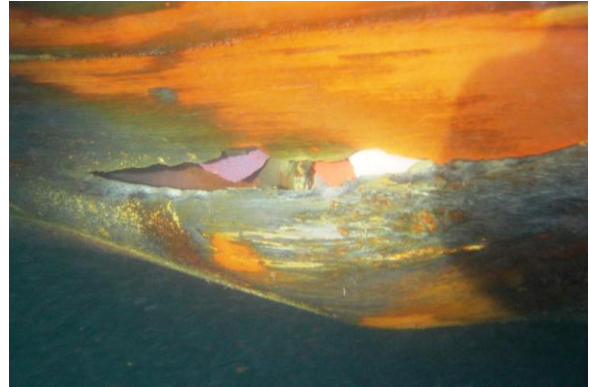
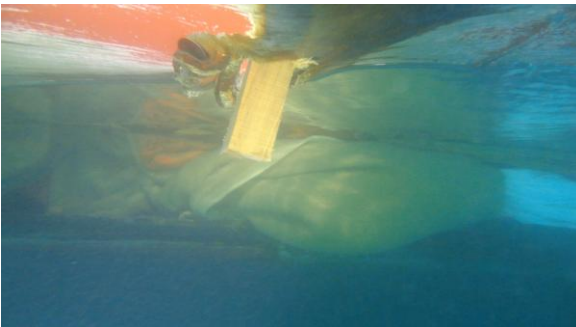
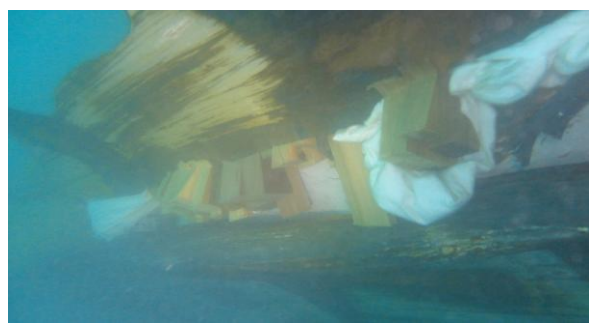
EUROPALINK severed extended hull damages (deformations and cracks and intends), as follows:

- port side from fr. 115 to fr. 204 (62,3 m)
- stbd side from fr. 82 to fr. 154 (50,4 m).

Several Void Spaces were also breached and engine room compartments were flooded. Damages to critical equipment such as her Main Engines, boilers, motors, pumps, electronic components, etc were

Photos from the bottom damage and counter flooding underwater operations carried out by the local divers' team

It was decided to shift her on the same dock and moor her alongside with her port side so as to unload trucks and vehicles through the stern ramp. The shifting operation was completed at approximately 1238. Following, the stern ramp was opened and the discharging operation of the garage spaces commenced while the team of two divers started chocking wooden wedges and other materials inside the breached bottom platings.

Europolink underwent temporary repairs and following an inspection by her Class, on 31 October 2014 she sailed under towage to Yalova shipyard in Turkey for drydocking.
