## SAFETY RECOMMENDATION No: 35/2015

05/2015: Fire onboard HSC Ro-Ro Passenger Ship HIGH SPEED 5, Flag Greece, IMO 9329095 and death of her Chief Electrician on 23<sup>rd</sup> March 2015 at Keratsini, Greece.

### **Fire onboard HSC Ro-Ro Passenger Ship HIGH SPEED 5, Flag Greece, IMO 9329095 and death of her Chief Electrician on 23<sup>rd</sup> March 2015 at Keratsini, Greece.**

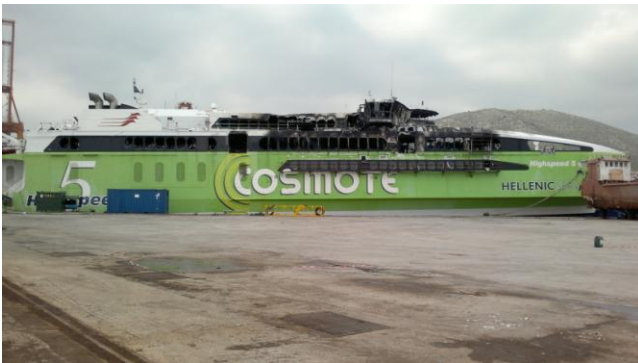
HIGHSPEED 5 sustained major damages, since all her accommodation compartments above the Upper Deck were completely destroyed. Her navigation bridge and all equipment were also destroyed.

**Figures 2 & 3:** General side views of the ship showing her extended damage.

1. The fire may have been caused due to the high temperature of the "Business" salon's top plating where welding works were being performed and the combustion of the adjacent insulation placed below it, which had not been removed, as would be appropriate.
2. The Master and the competent crew of HIGHSPEED 5 had not been informed regarding the execution of hot works above the "Business" salon on the day of the accident.
3. The crew's training regarding the procedure of entering an enclosed space had not been sufficient.
4. The Contractor of the conversion had not activated procedures regarding the application of safety measures according to the Safety Technician's recommendations.
5. The fire detection system was not activated due to the fact that there were no sensors inside the space between the top plating and the ceiling of the passengers' salon, where the fire was initially developed.

- the provision of a person's constant presence in the navigation bridge for the supervision of the fire detection and fire extinguishing systems.
2. Actions should be taken by the ship's Managing Company to examine the possibility of installing fire detectors inside the spaces covered by the accommodation spaces' ceilings.

3. Actions should be taken by the competent Hellenic Maritime Administration's Authorities regarding the assessment of:
  - the need of including the spaces covered by ceilings to those provided to be covered by fire detection sensors by the HSC Code,
