## SAFETY RECOMMENDATION No: 36/2014

04/2014: Impact of RoPax EUROPALINK on Peristerai Islet shoal reef.

### **Impact of RoPax EUROPALINK on Peristerai Islet shoal reef, Italian Flag, IMO 9319454**

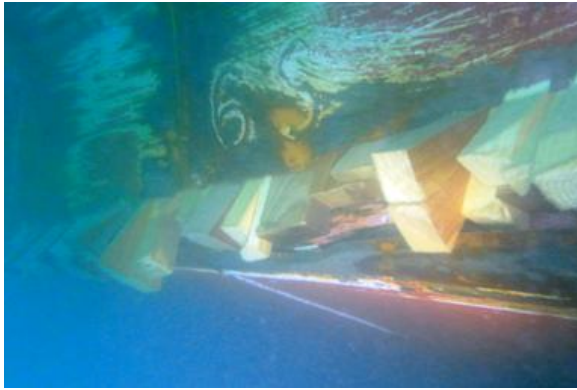
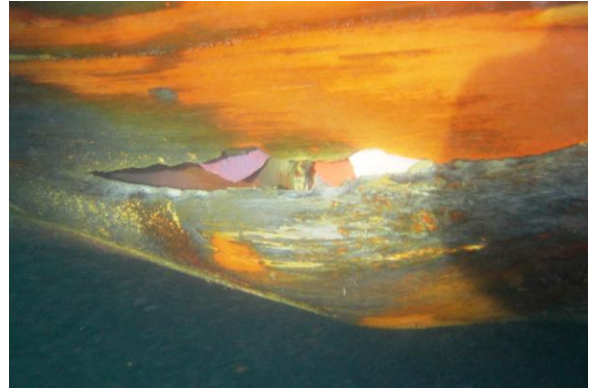
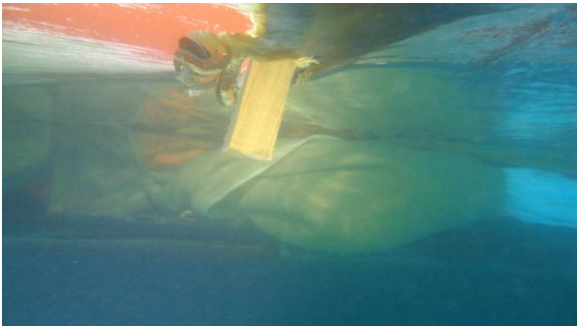
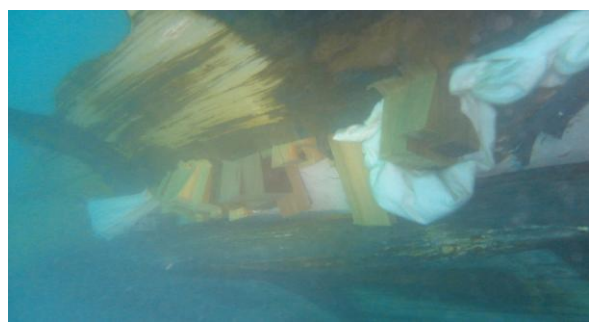
EUROPALINK severed extended hull damages (deformations and cracks and intends), as follows:

- port side from fr. 115 to fr. 204 (62,3 m)
- stbd side from fr. 82 to fr. 154 (50,4 m).

Several Void Spaces were also breached and engine room compartments were flooded. Damages to critical equipment such as her Main Engines, boilers, motors, pumps, electronic components, etc were reported.

Photos from the bottom damage and counter flooding underwater operations carried out by the local divers' team

It was decided to shift her on the same dock and moor her alongside with her port side so as to unload trucks and vehicles through the stern ramp. The shifting operation was completed at approximately 1238. Following, the stern ramp was opened and the discharging operation of the garage spaces commenced while the team of two divers started chocking wooden wedges and other materials inside the breached bottom platings.

Europolink underwent temporary repairs and following an inspection by her Class, on 31 October 2014 she sailed under towage to Yalova shipyard in Turkey for drydocking.
