SAFETY RECOMMENDATION No: 37/2015

05/2015: Fire onboard HSC Ro-Ro Passenger Ship HIGH SPEED 5, Flag Greece, IMO 9329095 and death of her Chief Electrician on 23rd March 2015 at Keratsini, Greece.

INFORMATION OF ACCIDENT

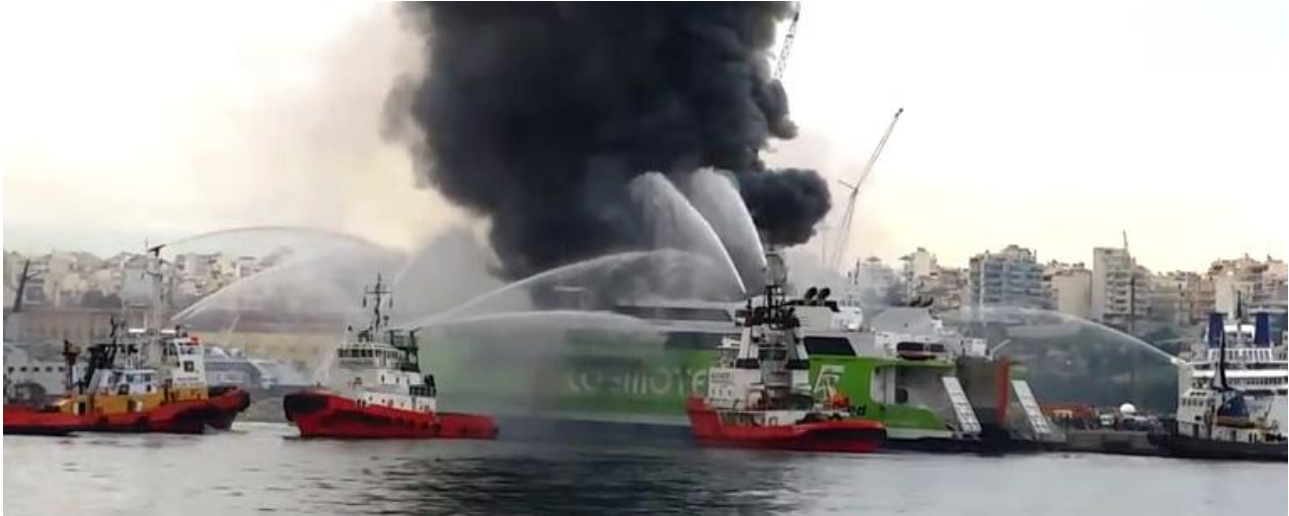
Figure 1: The deployment of the firefighting boats was imminent.

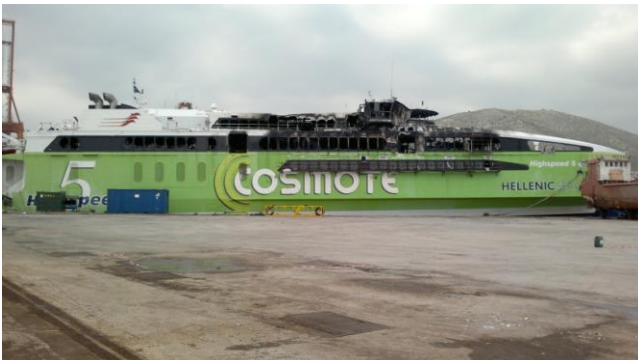
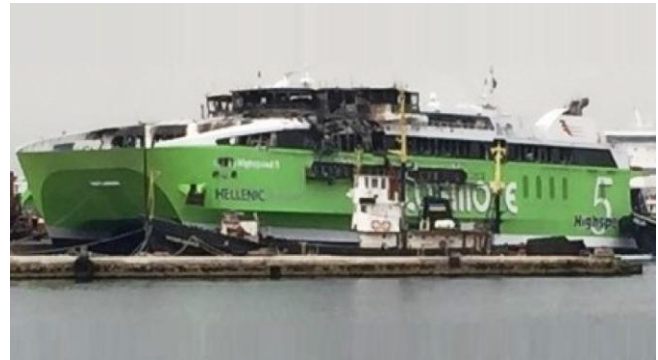
HIGHSPEED 5 sustained major damages, since all her accommodation compartments above the Upper Deck were completely destroyed. Her navigation bridge and all equipment were also destroyed.

Figures 2 & 3: General side views of the ship showing her extended damage.

1. The fire may have been caused due to the high temperature of the "Business" salon's top plating where welding works were being performed and the combustion of the adjacent insulation placed below it, which had not been removed, as would be appropriate.
2. The Master and the competent crew of HIGHSPEED 5 had not been informed regarding the execution of hot works above the "Business" salon on the day of the accident.
3. The crew's training regarding the procedure of entering an enclosed space had not been sufficient.
4. The Contractor of the conversion had not activated procedures regarding the application of safety measures according to the Safety Technician's recommendations.

5. The fire detection system was not activated due to the fact that there were no sensors inside the space between the top plating and the ceiling of the passengers' salon, where the fire was initially developed.

- the provision of a person's constant presence in the navigation bridge for the supervision of the fire detection and fire extinguishing systems.
2. Actions should be taken by the ship's Managing Company to examine the possibility of installing fire detectors inside the spaces covered by the accommodation spaces' ceilings.

3. Actions should be taken by the competent Hellenic Maritime Administration's Authorities regarding the assessment of:
 - the need of including the spaces covered by ceilings to those provided to be covered by fire detection sensors by the HSC Code,
