SAFETY RECOMMENDATION No: 39/2014

05/2014: Foundering of RoRo Cargo Agia Marina 25 nm West of Cape Gramvousa Kriti island.

The Togolese Maritime Administration

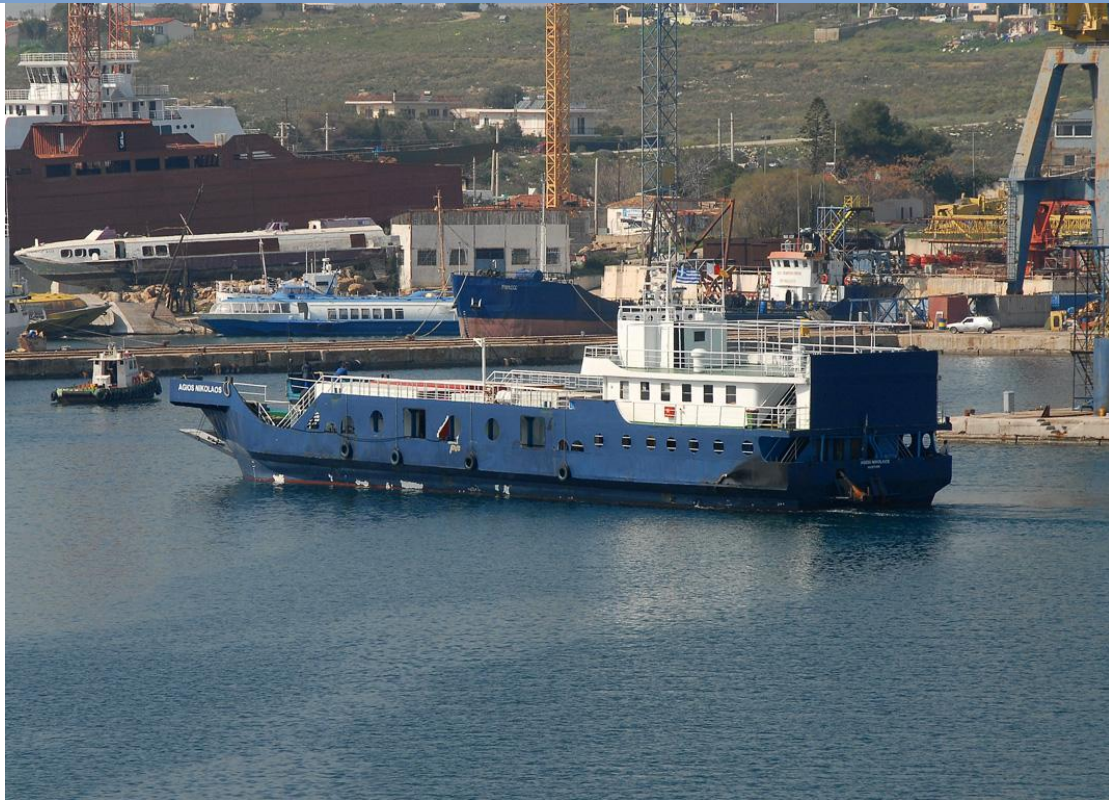
Figure 1: RoRo Cargo Agia Marina. The photo was taken by the time she was named Agios Nikolaos.

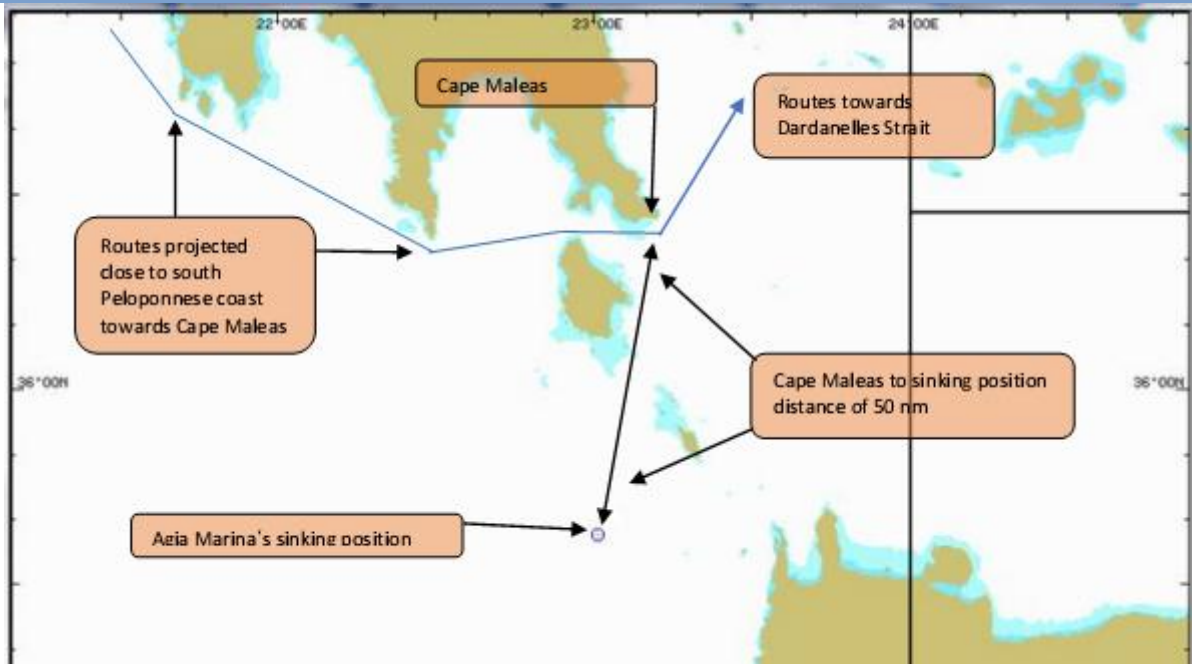
Figure 2: Sketch on electronic chart of the routes to be followed towards Dardanelles Strait compared with Agia Marina's sinking position.

7. The Navigational Officers failed to plan and conduct an appropriate passage plan in view of the intended voyage disregarding basic navigational methods under good seamanship and the safe operation of Agia Marina.
