## **SAFETY RECOMMENDATION No: 39/2015**

05/2015: Fire onboard HSC Ro-Ro Passenger Ship HIGH SPEED 5, Flag Greece, IMO 9329095 and death of her Chief Electrician on 23<sup>rd</sup> March 2015 at Keratsini, Greece.

Type of vessel: HSC Ro-Ro Passenger Ship

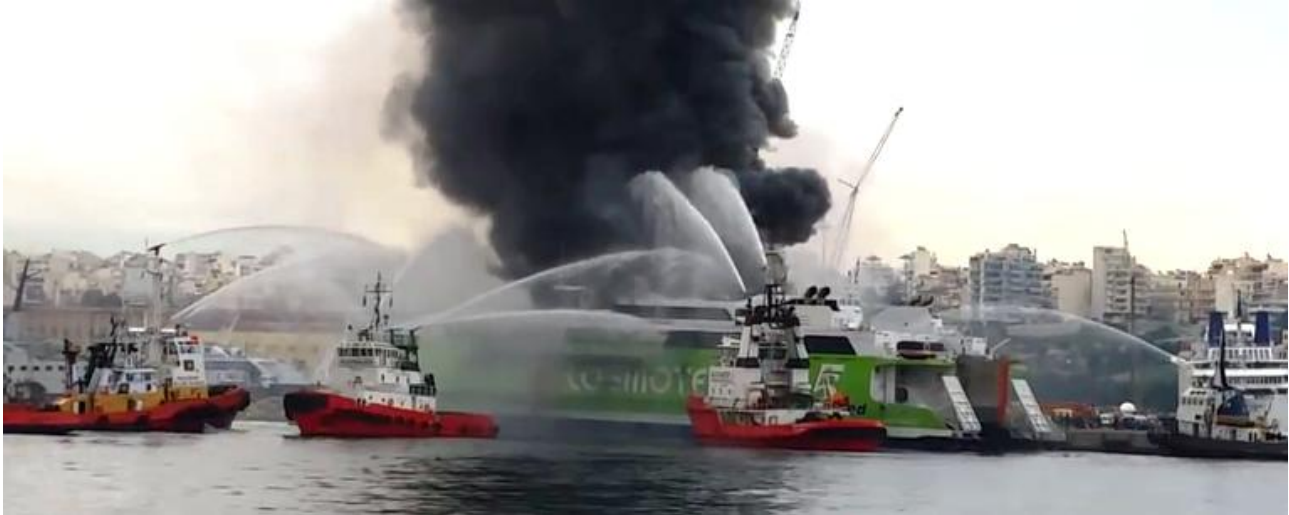
**Figure 1:** The deployment of the firefighting boats was imminent.

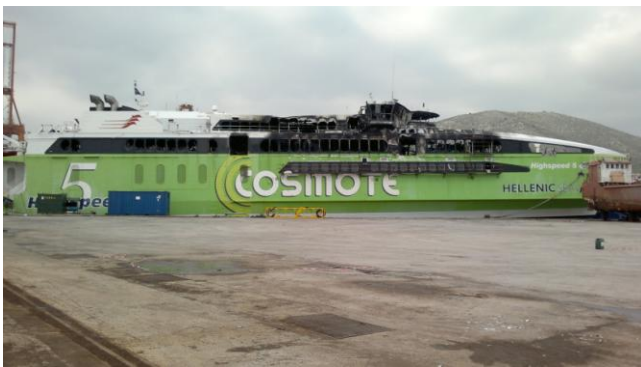
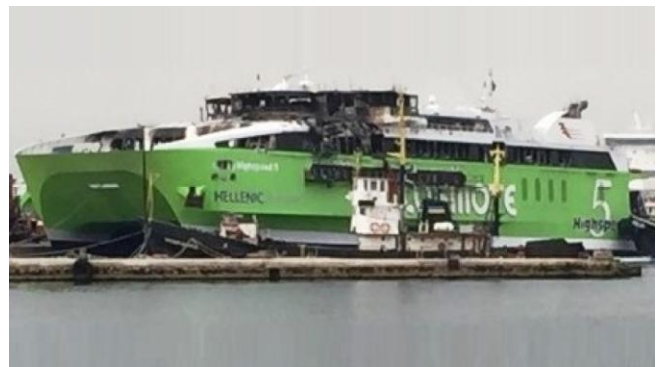
HIGHSPEED 5 sustained major damages, since all her accommodation compartments above the Upper Deck were completely destroyed. Her navigation bridge and all equipment were also destroyed.

**Figures 2 & 3:** General side views of the ship showing her extended damage.

1. The fire may have been caused due to the high temperature of the "Business" salon's top plating where welding works were being performed and the combustion of the adjacent insulation placed below it, which had not been removed, as would be appropriate.
2. The Master and the competent crew of HIGHSPEED 5 had not been informed regarding the execution of hot works above the "Business" salon on the day of the accident.
3. The crew's training regarding the procedure of entering an enclosed space had not been sufficient.
4. The Contractor of the conversion had not activated procedures regarding the application of safety measures according to the Safety Technician's recommendations.
5. The fire detection system was not activated due to the fact that there were no sensors inside the space

between the top plating and the ceiling of the passengers' salon, where the fire was initially developed.

- the provision of a person's constant presence in the navigation bridge for the supervision of the fire detection and fire extinguishing systems.
2. Actions should be taken by the ship's Managing Company to examine the possibility of installing fire detectors inside the spaces covered by the accommodation spaces' ceilings.

3. Actions should be taken by the competent Hellenic Maritime Administration's Authorities regarding the assessment of:
  - the need of including the spaces covered by ceilings to those provided to be covered by fire detection sensors by the HSC Code,
