SAFETY RECOMMENDATION No: 40/2014

No of Safety Investigation Report:	06/2014: Fatal fall into the sea of technician during disembarkation from Oil Tanker ROYAL OAK to launch boat DRAKON TAXIARCHIS (See the full Report here.)
Safety Recommendation addressed to:	ROYAL OAK Managers
Date of publication:	24/01/2017
Comments-Remarks:

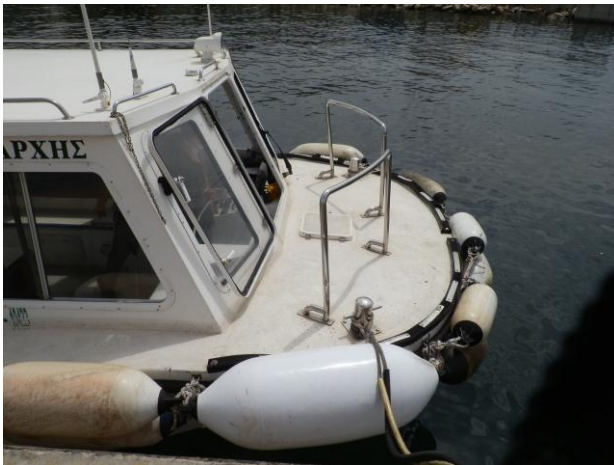
The fore embarkation deck of launch boat DRAKON TAXIARCHIS

- A second crew member on the launch boat could contribute to avoid unsafe situations during boarding with rippled sea causing rolling and pitching or during emergency response actions.

- The location of the launch boat's liferings provided easy and quick use, however it contributed to a short delay as it was at a distance from the fore embarkation deck.

- On passenger launch boats the risk of a person falling overboard increases during embarkation / disembarkation, especially when performed at anchorages where the sea area is open and the weather conditions are heavier in respect to weather conditions in ports.
Placing liferings as close as possible to the embarkation / disembarkation points could minimize the time required to throw them and enhance the effectiveness of emergency response to a “man overboard” incident.
- The use of Personal Floating Device or other buoyancy equipment during embarkation / disembarkation procedure on vessels by launch boats is not required by the existing regulatory framework, however, it is considered as an key factor for an effective emergency response of “man overboard” incident which may occur during said procedure.
