SAFETY RECOMMENDATION No: 40/2015

05/2015: Fire onboard HSC Ro-Ro Passenger Ship HIGHSPEED 5, Flag Greece, IMO 9329095 and death of her Chief Electrician on 23rd March 2015 at Keratsini, Greece.

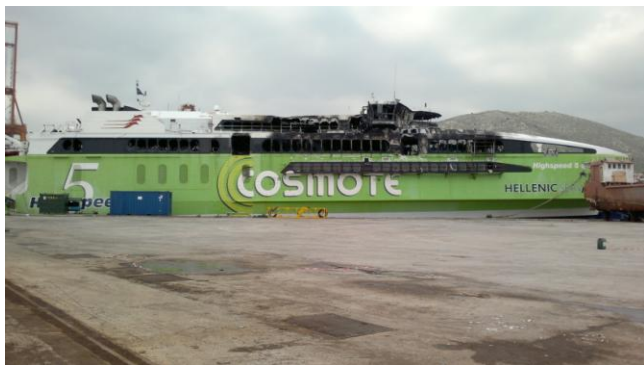
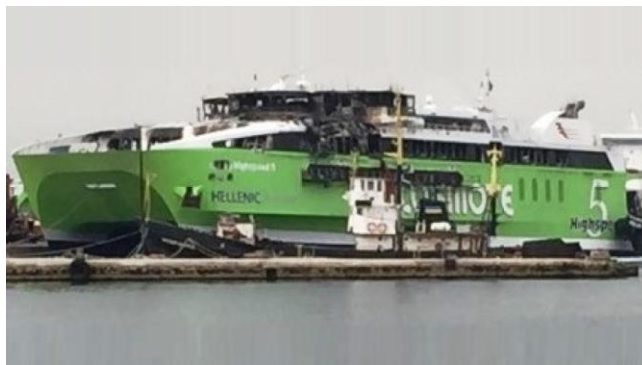
HIGHSPEED 5 sustained major damages, since all her accommodation compartments above the Upper Deck were completely destroyed. Her navigation bridge and all equipment were also destroyed.

Figures 2 & 3: General side views of the ship showing her extended damage.

1. The fire may have been caused due to the high temperature of the "Business" salon's top plating where welding works were being performed and the combustion of the adjacent insulation placed below it, which had not been removed, as would be appropriate.
2. The Master and the competent crew of HIGHSPEED 5 had not been informed regarding the execution of hot works above the "Business" salon on the day of the accident.
3. The crew's training regarding the procedure of entering an enclosed space had not been sufficient.
4. The Contractor of the conversion had not activated procedures regarding the application of safety measures according to the Safety Technician's recommendations.
5. The fire detection system was not activated due to the fact that there were no sensors inside the space between the top plating and the ceiling of the passengers' salon, where the fire was initially developed.

4. Actions should be taken by the Port Authority in view of providing more than one evacuation exits towards the pier for ships conducting conversion works and in view of providing a "Fire Safety Team" with the duty of conducting daily inspections on vessels for the prevention of fire.
