SAFETY RECOMMENDATION No: 41/2014

06/2014: Fatal fall into the sea of technician during disembarkation from Oil Tanker ROYAL OAK to launch boat DRAKON TAXIARCHIS
(See the full Report [here.](#))

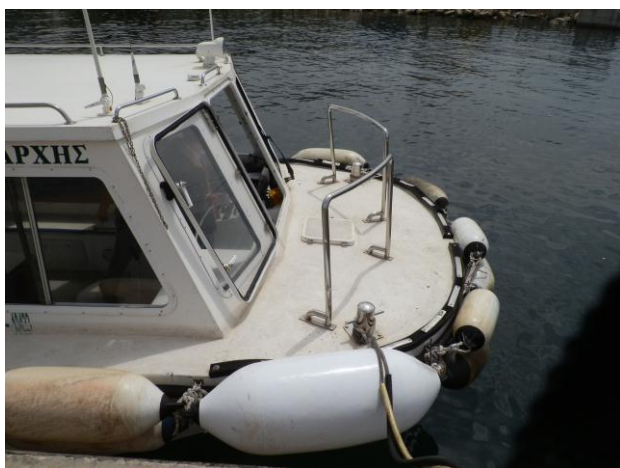
The fore embarkation deck of launch boat DRAKON TAXIARCHIS

- The location of the launch boat's liferings provided easy and quick use, however it contributed to a short delay as it was at a distance from the fore embarkation deck.

- On passenger launch boats the risk of a person falling overboard increases during embarkation / disembarkation, especially when performed at anchorages where the sea area is open and the weather conditions are heavier in respect to weather conditions in ports.
Placing liferings as close as possible to the embarkation / disembarkation points could minimize the time required to throw them and enhance the effectiveness of emergency response to a “man overboard” incident.
- The use of Personal Floating Device or other buoyancy equipment during embarkation / disembarkation procedure on vessels by launch boats is not required by the existing regulatory framework, however, it is considered as an key factor for an effective emergency response of “man overboard” incident which may occur during said procedure.
