SAFETY RECOMMENDATION No: 42/2013

No of Safety Investigation Report:	07/2013: Impact of M/T "MANTOUDI" with the pier <i>(See the full Report here.)</i>
---	---

Impact of M/T with the pier

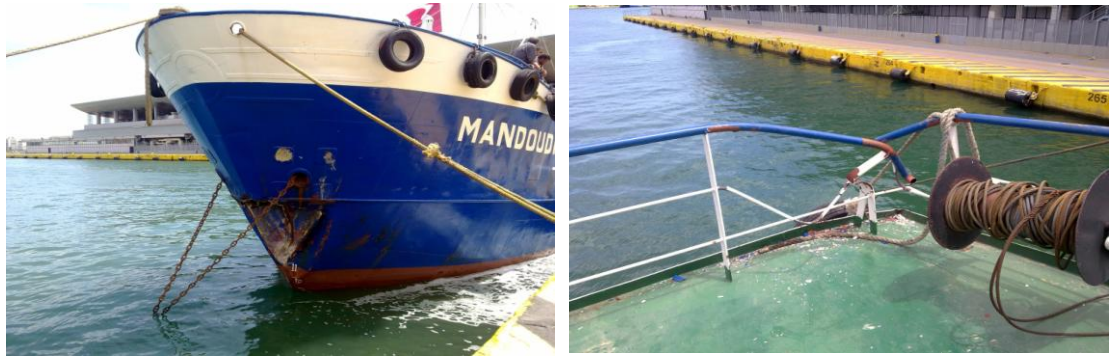
The M/T sustained a crack at the tank top of the Fore Peak Tank, buckling and cracking of stiffeners inside the Fore Peak Tank and buckling of the central longitudinal bulkhead, buckling of the hull plate at a height of 0,50m above the waterline, cracking at the top of said buckling and deformation of the railings on the bridge deck on the starboard side.

Pictures 2, 3: The damages of the M/T externally (left: fore part, right: railings on the starboard bridge deck)

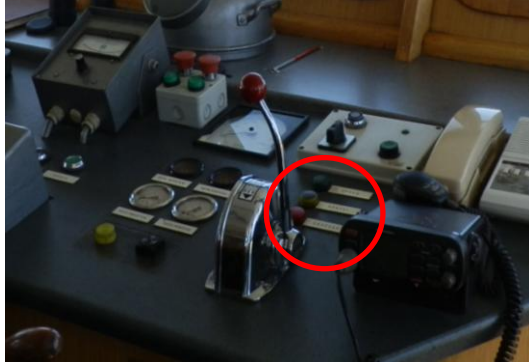
Picture 4: View of the direction drive control lever where the indicative position lights are shown (inside the red circle)
