SAFETY RECOMMENDATION No: 42/2014

No of Safety Investigation Report:

06/2014: Fatal fall into the sea of technician during disembarkation from Oil Tanker ROYAL OAK to launch boat DRAGON TAXIARCHIS
(See the full Report [here.](#))

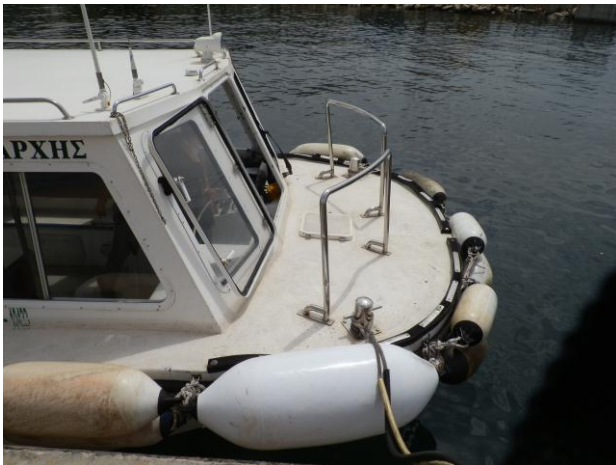
*The fore embarkation deck of launch boat
DRAKON TAXIARCHIS*

- The location of the launch boat's liferings provided easy and quick use, however it contributed to a short delay as it was at a distance from the fore embarkation deck.

Consider supplementing the launch boat's manning with one crew member when the prevailing conditions upgrade the risk of "man overboard".
