SAFETY RECOMMENDATION No: 44/2013

No of Safety Investigation Report:	07/2013: Impact of M/T "MANTOUDI" with the pier (See the full Report here.)
---	---

Impact of M/T with the pier

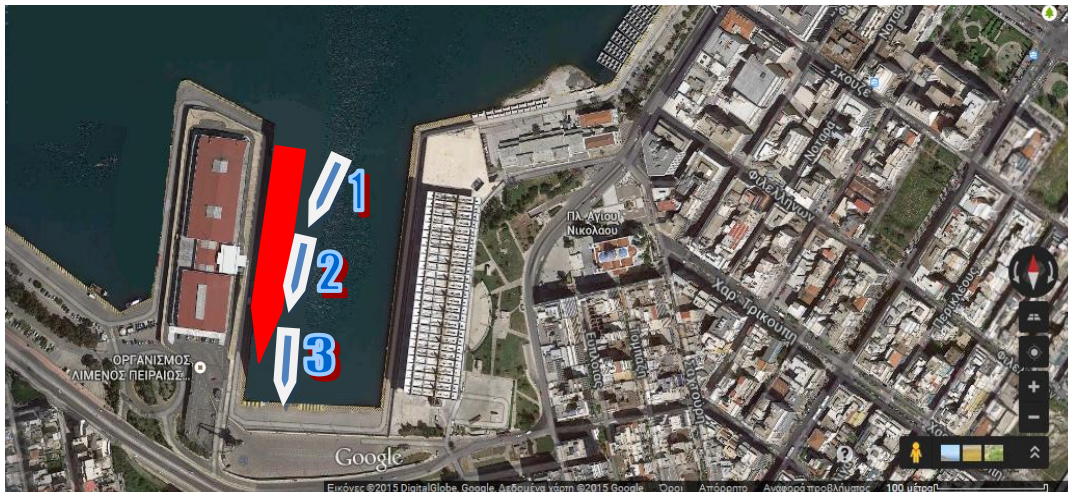
Picture 1: View of the area of Pier No.3 (Xaveri Coast) in the Central Port of Piraeus. The positions of the ships involved, SEABOURNSPIRIT (red) and MANTOUDI (white - blue) are shown (without the use of a scale) as follows:

- 1: MANTOUDI approach for mooring to SEABOURNSPIRIT
 - 2: MANTOUDI not able to reduce speed
 - 3: MANTOUDI impacts with the jetty
- (Map Source: Google Maps)
