SAFETY RECOMMENDATION No: 44/2014

06/2014: Fatal fall into the sea of technician during disembarkation from Oil Tanker ROYAL OAK to launch boat DRAKON TAXIARCHIS
(See the full Report [here.](#))

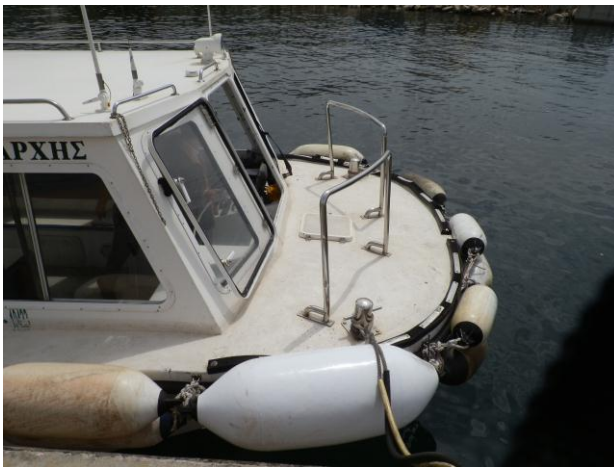
*The fore embarkation deck of launch boat
DRAKON TAXIARCHIS*

- The location of the launch boat's liferings provided easy and quick use, however it contributed to a short delay as it was at a distance from the fore embarkation deck.

Consider supplementing DRAKON TAXIARCHIS Certificate of General Inspection with a guideline indicating the embarkation / disembarkation areas close to which a lifering with line should be placed.
