SAFETY RECOMMENDATION No: 44/2015

06/2015: Grounding and foundering of M/V KEREM S, St. Vincent & the Grenadines Flag, IMO 8223127, at Levitha Island, Greece.

The Managing Company of "KEREM S"

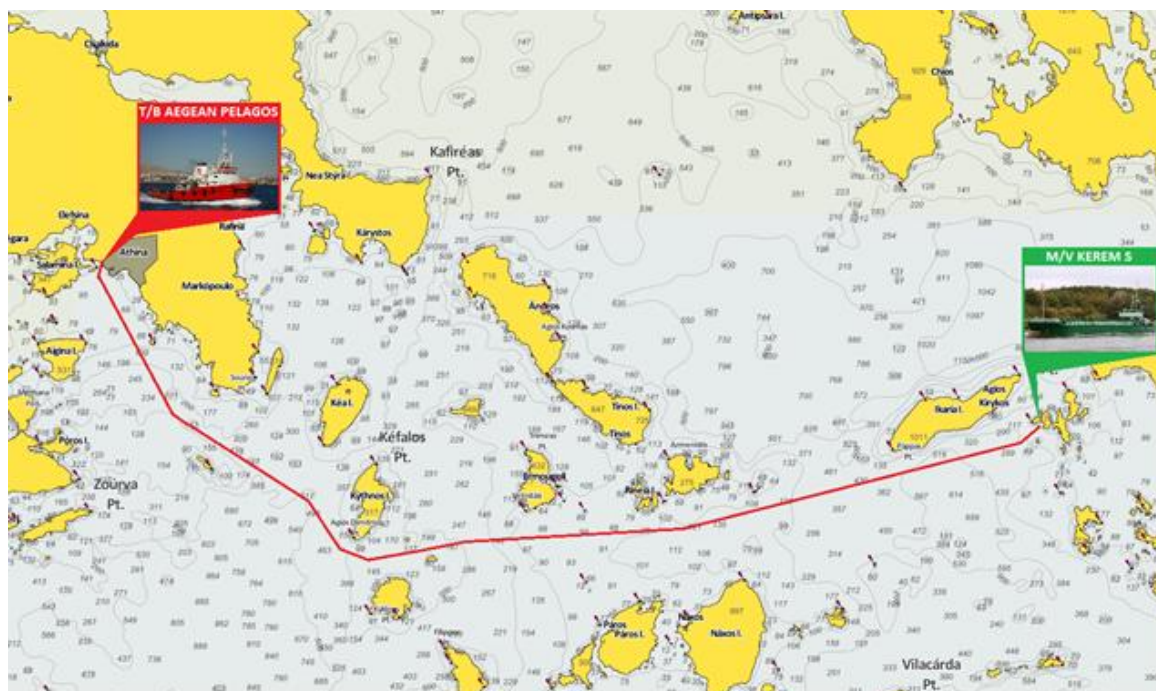
The passage from Piraeus to Thymaina, approximately 160 nm.

5. The ship's Managing Company arranged for assistance by a tugboat located approximately 160 nm away from the casualty position and needed almost 14 hours to arrive at the vessel's area.
