SAFETY RECOMMENDATION No: 45/2013

No of Safety Investigation Report:	07/2013: Impact of M/T "MANTOUDI" with the pier <i>(See the full Report here.)</i>
---	---

Impact of M/T with the pier

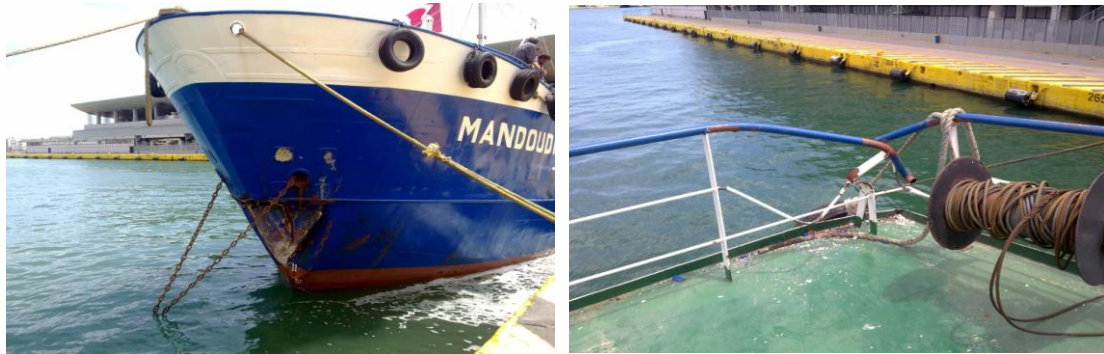
The M/T sustained a crack at the tank top of the Fore Peak Tank, buckling and cracking of stiffeners inside the Fore Peak Tank and buckling of the central longitudinal bulkhead, buckling of the hull plate at a height of 0,50m above the waterline, cracking at the top of said buckling and deformation of the railings on the bridge deck on the starboard side.

Pictures 2, 3: The damages of the M/T externally (left: fore part, right: railings on the starboard bridge deck)

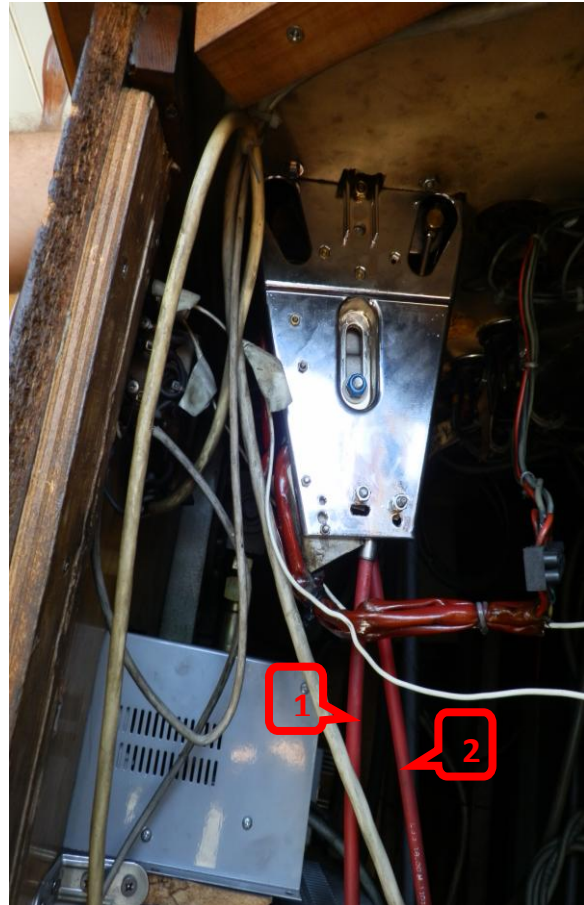
The malfunction of the of the Main Engine's remote control system at the bridge caused by the loosening of the control head cable "Ω" type fastener screws, probably from the effect of the vibrations presented during the ship's operation.

The same malfunction of the remote control system of the main engine had occurred one month before the examined accident, and had contributed to the decision for the replacement of the control system with a new one which was installed by the ship's Engineer and by her Owner, according to the manufacturer's instructions (manual).

Picture 5: View of the lower part of the control system where the cables towards the engine room have been marked.

- 1: Main Engine direction control cable
- 2: Main Engine revolutions control cable

Establishing a system of periodical checks of the vessel's control unit, according to the instructions provided by its manufacturer.
