SAFETY RECOMMENDATION No: 45/2015

No of Safety Investigation Report:	07/2015: Grounding of B/C "GOODFAITH" (See the full Report here.)
Safety Recommendation addressed to:	Managers
Date of publication:	13/12/2017

Grounding of B/C "GOODFAITH"

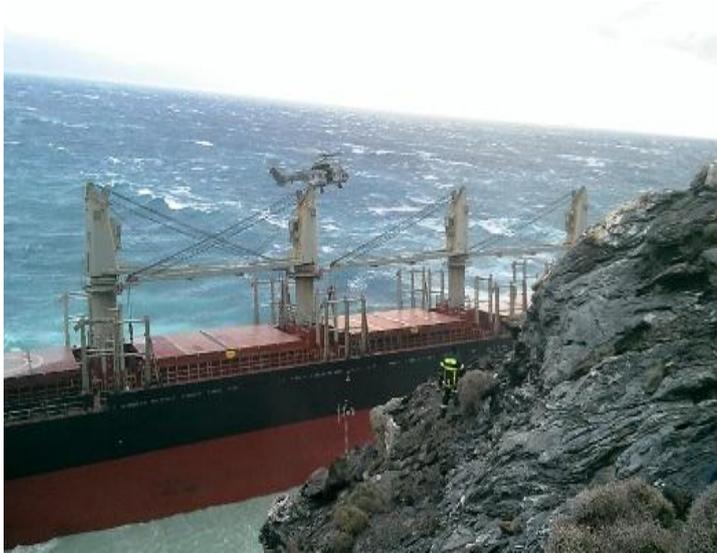
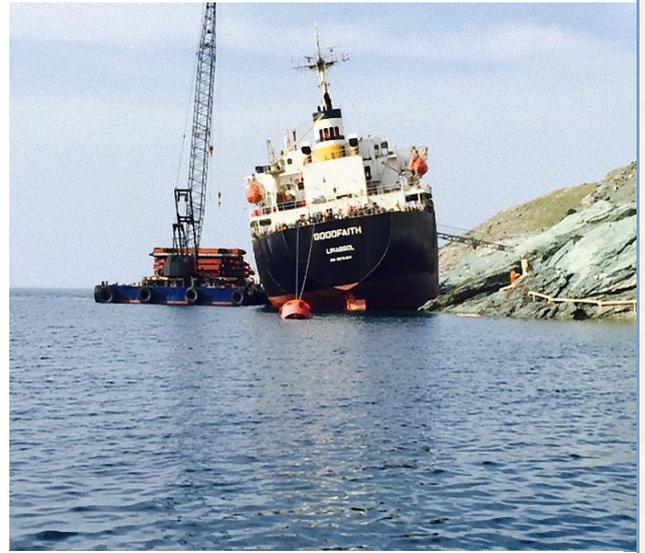
M/V Goodfaith had sustained severe damages, heavy indentations, cracks and fractures lengthwise on her bottom and side shell plating, including underwater hull damages in her fore section, cargo holds and engine room. It was apparent that the repair costs exceeded the insured value of the vessel therefore she was considered a constructive total loss. M/V Goodfaith was towed on the 10th of July 2015 from Andros to a shipyard facility in Salamis island (Greece) until her final destination to the demolition yard for its disposal on the 17th of October 2015.

Photos from the SAR operation and the vessel being removed from the casualty area
