## SAFETY RECOMMENDATION No: 46/2013

<b>No of Safety Investigation Report:</b>	07/2013: Impact of M/T “MANTOUDI” with the pier (See the full Report <a href="#">here.</a> )
---	---

### **Impact of M/T with the pier**

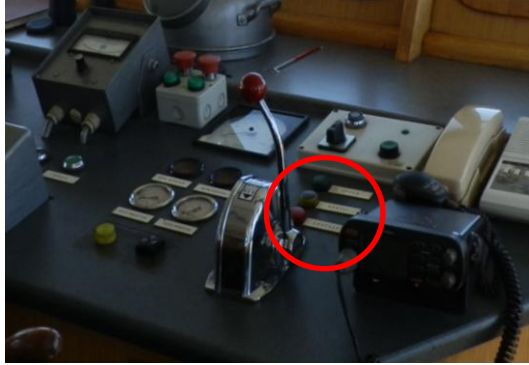
**Picture 4:** View of the direction drive control lever where the indicative position lights are shown (inside the red circle)
