## SAFETY RECOMMENDATION No: 46/2014

Consider supplementing the existing regulatory framework so that the embarkation / disembarkation areas of the launch boats should be recorded on the issued Certificates of General Inspections and that a lifering with line should be placed close to them.

06/2014: Fatal fall into the sea of technician during disembarkation from Oil Tanker ROYAL OAK to launch boat DRAKON TAXIARCHIS  
(See the full Report [here.](#))

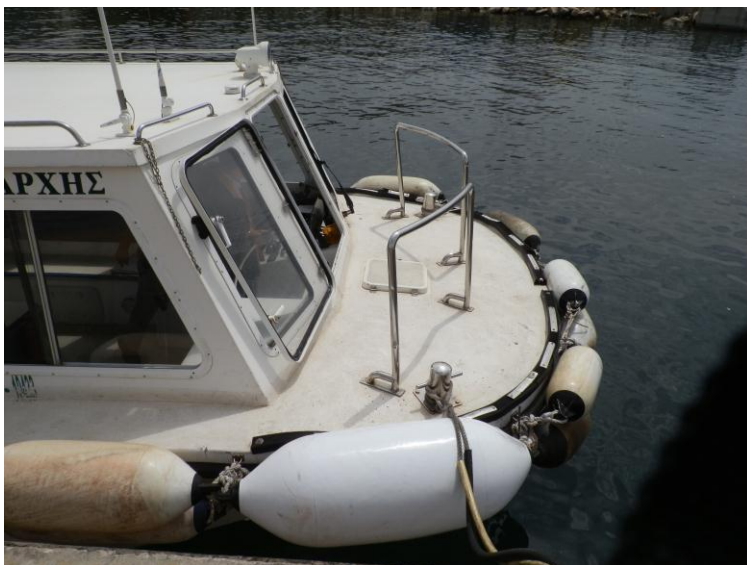
*The fore embarkation deck of launch boat DRAGON TAXIARCHIS*

- The location of the launch boat's liferings provided easy and quick use, however it contributed to a short

delay as it was at a distance from the fore embarkation deck.

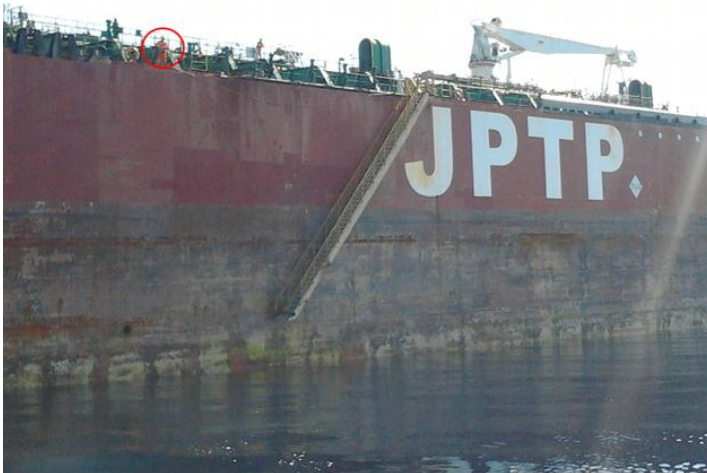
*The Starboard accommodation ladder of M/T ROYAL OAK.*

According to data obtained during the interview process, when the launch boat was close to the ladder and after the technician handed over a sonar device to the C/O positioned at the bow of the launch, he attempted to embark, however his movement was slow and not at the right time since it was performed when the boat was moving downwards and away from the ladder's platform.
