SAFETY RECOMMENDATION No: 46/2015

07/2015: Grounding of B/C "GOODFAITH"
(See the full Report [here.](#))

Grounding of B/C "GOODFAITH"

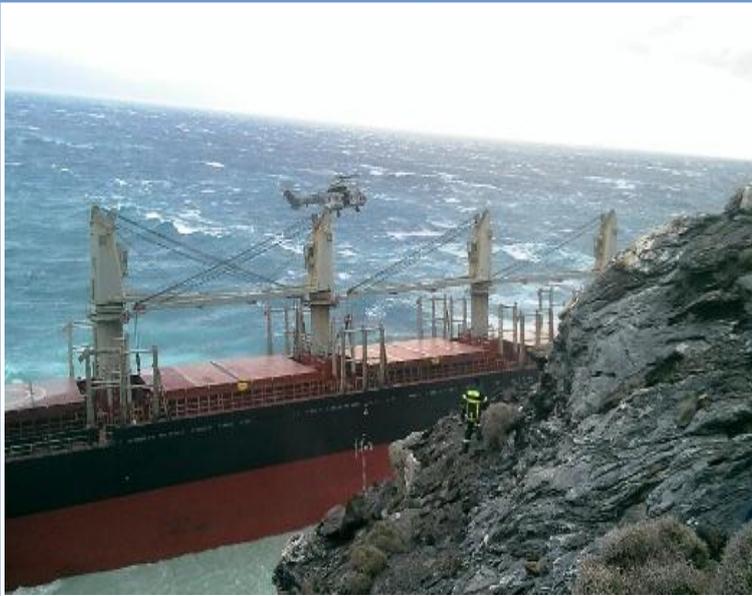
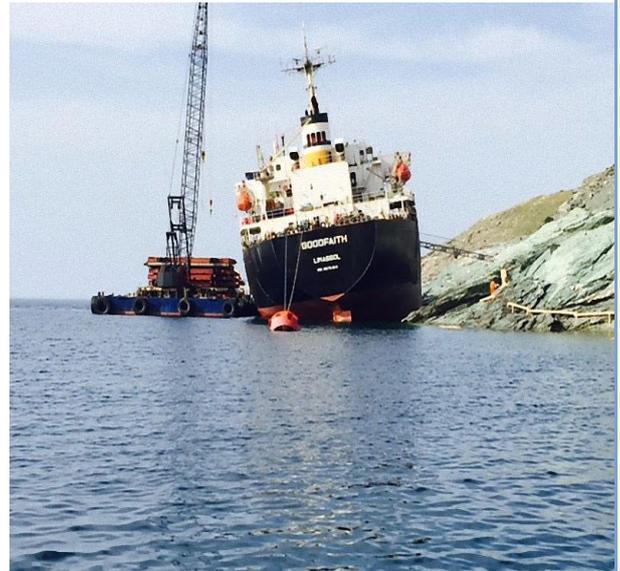
M/V Goodfaith had sustained severe damages, heavy indentations, cracks and fractures lengthwise on her bottom and side shell plating, including underwater hull damages in her fore section, cargo holds and engine room. It was apparent that the repair costs exceeded the insured value of the vessel therefore she was considered a constructive total loss. M/V Goodfaith was towed on the 10th of July 2015 from Andros to a shipyard facility in Salamis island (Greece) until her final destination to the demolition yard for its disposal on the 17th of October 2015.

Photos from the SAR operation and the vessel being removed from the casualty area
