SAFETY RECOMMENDATION No: 47/2014

06/2014: Fatal fall into the sea of technician during disembarkation from Oil Tanker ROYAL OAK to launch boat DRAKON TAXIARCHIS
(See the full Report [here.](#))

Piraeus Central Port Authority

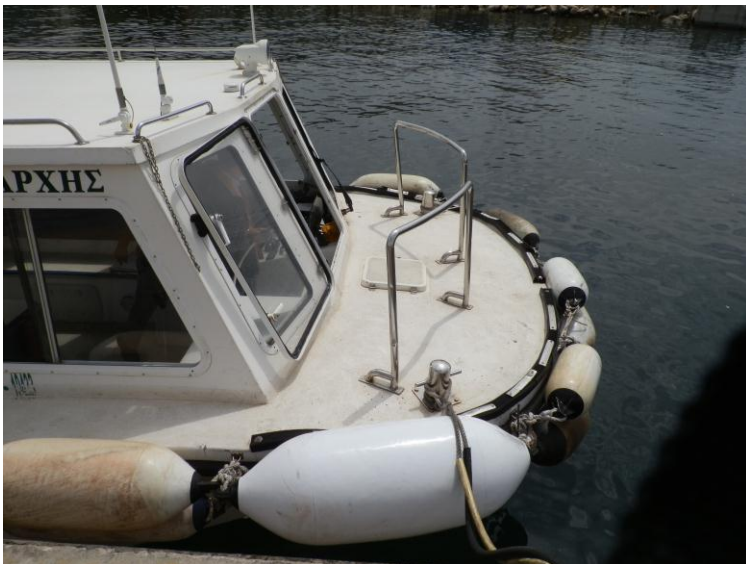
*The fore embarkation deck of launch boat
DRAKON TAXIARCHIS*

- The location of the launch boat's liferings provided easy and quick use, however it contributed to a short

delay as it was at a distance from the fore embarkation deck.

- On passenger launch boats the risk of a person falling overboard increases during embarkation / disembarkation, especially when performed at anchorages where the sea area is open and the weather conditions are heavier in respect to weather conditions in ports.
Placing liferings as close as possible to the embarkation / disembarkation points could minimize the time required to throw them and enhance the effectiveness of emergency response to a “man overboard” incident.
- The use of Personal Floating Device or other buoyancy equipment during embarkation / disembarkation procedure on vessels by launch boats is not required by the existing regulatory framework, however, it is considered as an key factor for an effective emergency response of “man overboard” incident which may occur during said procedure.
