SAFETY RECOMMENDATION No: 47/2015

07/2015: Grounding of B/C "GOODFAITH"
(See the full Report [here.](#))

Grounding of B/C "GOODFAITH"

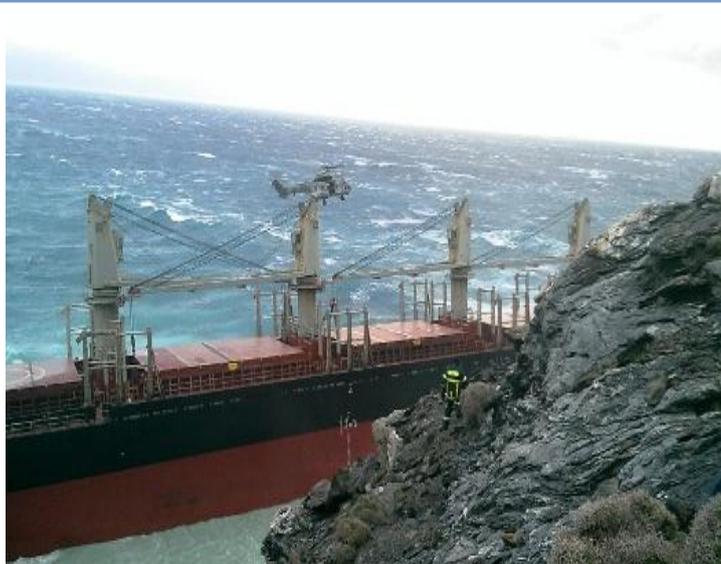
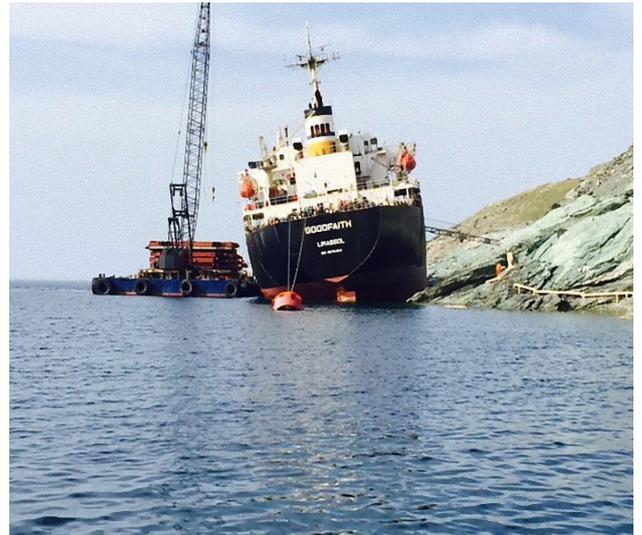
M/V Goodfaith had sustained severe damages, heavy indentations, cracks and fractures lengthwise on her bottom and side shell plating, including underwater hull damages in her fore section, cargo holds and engine room. It was apparent that the repair costs exceeded the insured value of the vessel therefore she was considered a constructive total loss. M/V Goodfaith was towed on the 10th of July 2015 from Andros to a shipyard facility in Salamis island (Greece) until her final destination to the demolition yard for its disposal on the 17th of October 2015.

Photos from the SAR operation and the vessel being removed from the casualty area
