SAFETY RECOMMENDATION No: 48/2014

06/2014: Fatal fall into the sea of technician during disembarkation from Oil Tanker ROYAL OAK to launch boat DRAGON TAXIARCHIS
(See the full Report [here.](#))

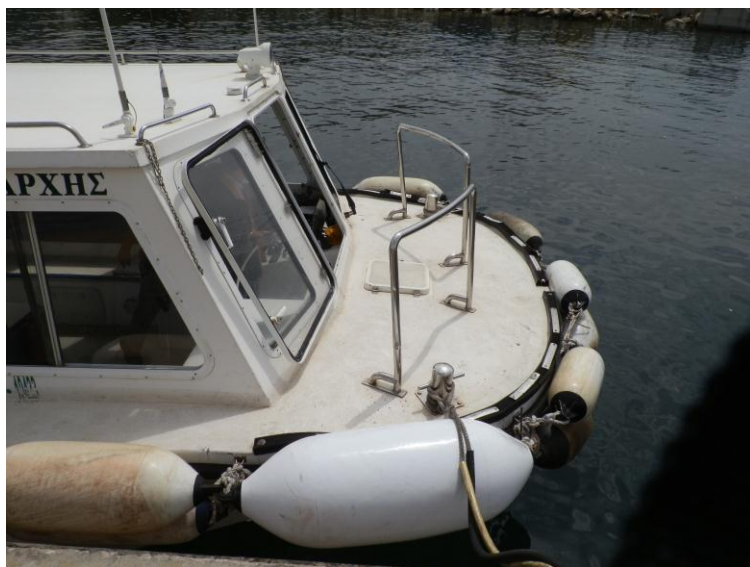
The fore embarkation deck of launch boat DRAGON TAXIARCHIS

- The location of the launch boat's liferings provided easy and quick use, however it contributed to a short

delay as it was at a distance from the fore embarkation deck.

- On passenger launch boats the risk of a person falling overboard increases during embarkation / disembarkation, especially when performed at anchorages where the sea area is open and the weather conditions are heavier in respect to weather conditions in ports.
Placing liferings as close as possible to the embarkation / disembarkation points could minimize the time required to throw them and enhance the effectiveness of emergency response to a “man overboard” incident.
- The use of Personal Floating Device or other buoyancy equipment during embarkation / disembarkation procedure on vessels by launch boats is not required by the existing regulatory framework, however, it is considered as an key factor for an effective emergency response of “man overboard” incident which may occur during said procedure.
