SAFETY RECOMMENDATION No: 48/2015

07/2015: Grounding of B/C “GOODFAITH”
(See the full Report [here.](#))

Grounding of B/C “GOODFAITH”

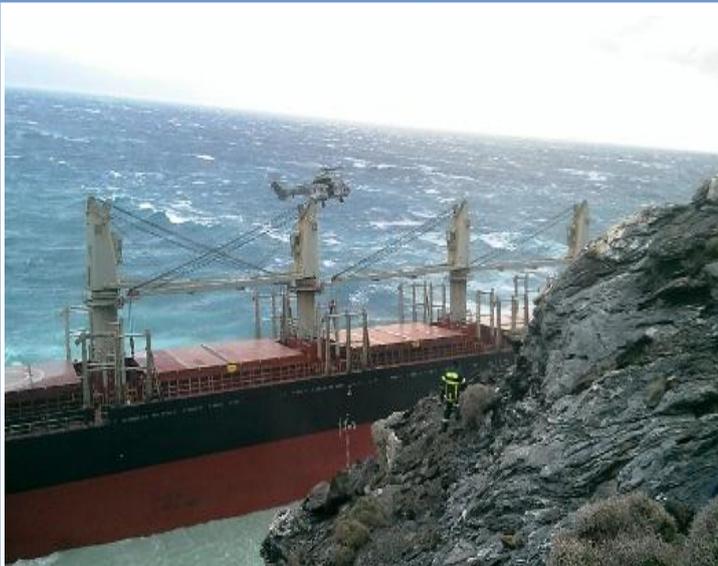
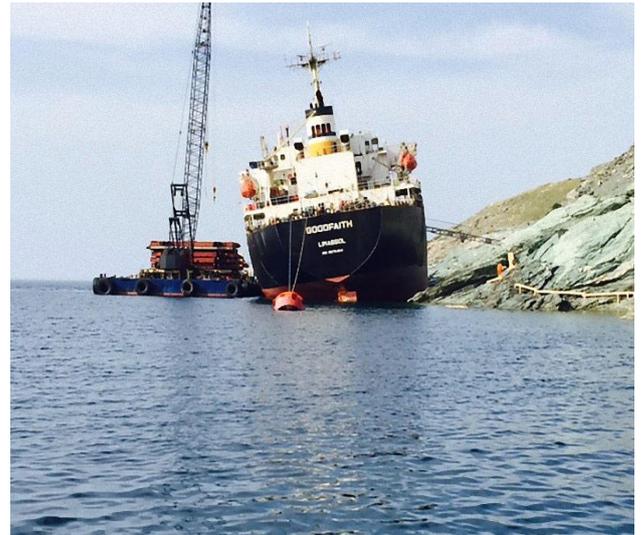
M/V Goodfaith had sustained severe damages, heavy indentations, cracks and fractures lengthwise on her bottom and side shell plating, including underwater hull damages in her fore section, cargo holds and engine room. It was apparent that the repair costs exceeded the insured value of the vessel therefore she was considered a constructive total loss. M/V Goodfaith was towed on the 10th of July 2015 from Andros to a shipyard facility in Salamis island (Greece) until her final destination to the demolition yard for its disposal on the 17th of October 2015.

Photos from the SAR removal operation and the vessel being removed from the casualty area
