## SAFETY RECOMMENDATION No: 49/2014

07/2014: **FATAL FALL OF BOSUN FROM THE DECK CRANE OF B/C «PANORIA»** Flag Greece IMO: 9480930

## FATAL FALL OF BOSUN FROM THE DECK CRANE OF B/C «PANORIA»

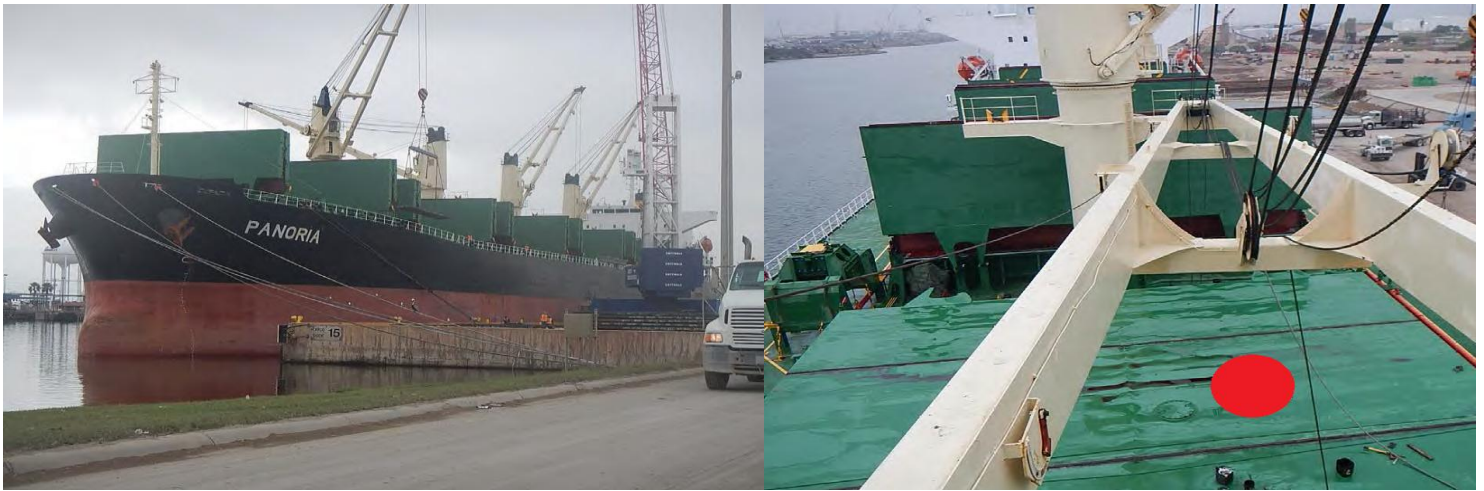
When he reached to the cross section he attached his safety harness to the old wire that was being replaced. While he was standing on the jib's cross section he lost his balance and fell from a height of 9.5 meters on the cargo hold's hatch cover. The safety harness did not prevent his fall as the old wire rope was not secured to any fixed point and was hanging free.

Vessel's berthing position at Brownsville, Texas, USA

The location where the Bosun fell on top of cargo hatch cover No.3
