## SAFETY RECOMMENDATION No: 52/2015

08/2015: Death of one fisherman onboard F/V "LIVERIS FOTINI II", Flag Greece, Reg. no Kavala 313 on 13<sup>rd</sup> April 2015 at Keramoti, Greece

### **Death of one fisherman onboard F/V "LIVERIS FOTINI II", Flag Greece, Reg. no Kavala 313 on 13rd April 2015 at Keramoti, Greece.**

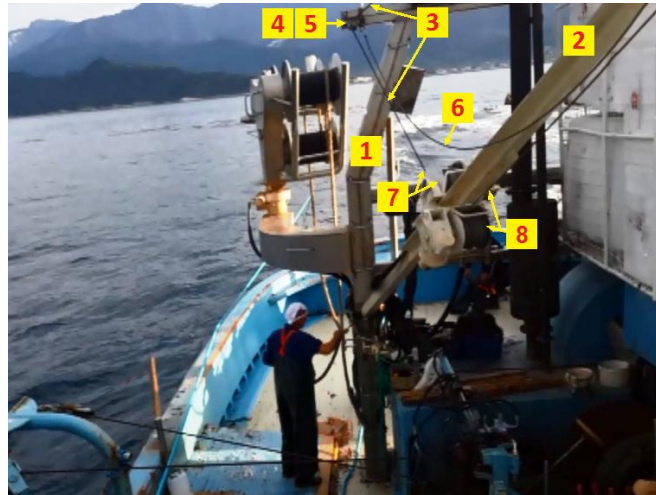
**Picture 1:** Photo taken during the vessel’s operation a few months prior to the casualty. The following crane parts are indicated:

1. The supporting frame of the crane, 2. The crane boom, 3. The boom holding line which also performed the lifting and lowering of the boom and its corresponding winch (no 7), 4. The line’s guiding roller, 5. The line holding pad eye, 6. The boom safety line, 8. The hook line and its corresponding winch.

At approximately 10:00 am and while cleaning, painting and portable equipment adjusting operations were being performed by some of the fishermen, without the Captain’s presence, the pad eye holding the boom line (item 5 of Picture 1), detached from the metal frame and the boom’s upper end fell on one of the fishermen, aged 41, injuring him deadly on the head. The safety line was not in place as it had been removed by one of the fishermen during the crane’s painting a few days prior to the casualty.

1. The fisherman’s fatal injury was caused by the fall of the crane boom due to the fracture of the welding of the pad eye which held the boom lifting line. The welding had defects due to its improper construction. The safety line pad eye welding was also found to be defective.

2. The technician who had performed the crane’s construction was not qualified for such work.
3. On the day of the casualty the safety line was not at place, as it had been previously removed by the F/V fishermen, in order the crane to be painted.

1. Actions should be taken by the ship's Operator/Captain to:
  - Inspect the safety line pad eye welding by a competent technician.
  - Comply with the regulations provided by the national legal framework regarding the vessel's lifting appliances.

- the use of personal protective equipment during their work.
2. Actions should be taken by the ship's certifying Organization in order the inspection process for the lifting appliances of F/V of less than 100 GRT to be amended and include load testing periodically after their installation.
