SAFETY RECOMMENDATION No: 55/2014

07/2014: **FATAL FALL OF BOSUN FROM THE DECK CRANE OF B/C «PANORIA»** Flag Greece IMO: 9480930

FATAL FALL OF BOSUN FROM THE DECK CRANE OF B/C «PANORIA»

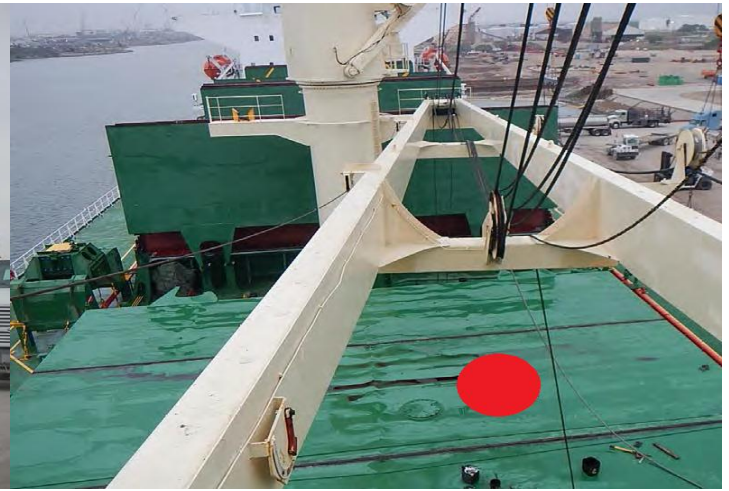
standing on the jib's cross section he lost his balance and fell from a height of 9.5 meters on the cargo hold's hatch cover. The safety harness did not prevent his fall as the old wire rope was not secured to any fixed point and was hanging free.

The location where the Bosun fell on top of cargo hatch cover No.3
