SAFETY RECOMMENDATION No: 56/2013

09/2013: Impact of MSC Magnifica on Piraeus Port entrance breakwater.

Impact of MSC Magnifica on Piraeus Port entrance breakwater

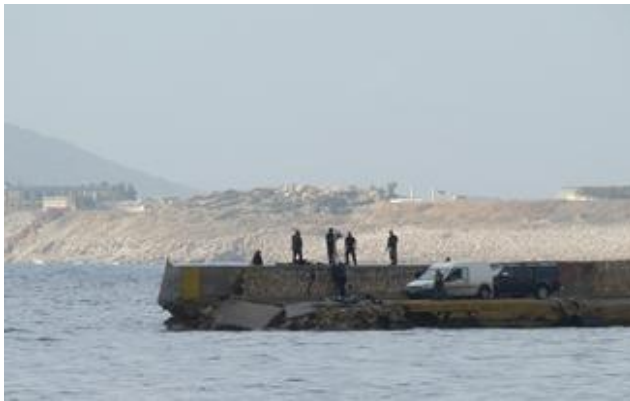
1. structural damages :
 - crack on port bow section above the waterline
 - deformation and intends and scratches on port side shell plating lengthwise under the waterline
 - indent at port aft quarter close to stern post
2. Piraeus' port entrance breakwater
 - Port entrance breakwater's head damaged
 - concrete round-hut red light detached and collapsed into the sea

Figure 2: *The damaged head of the breakwater .*

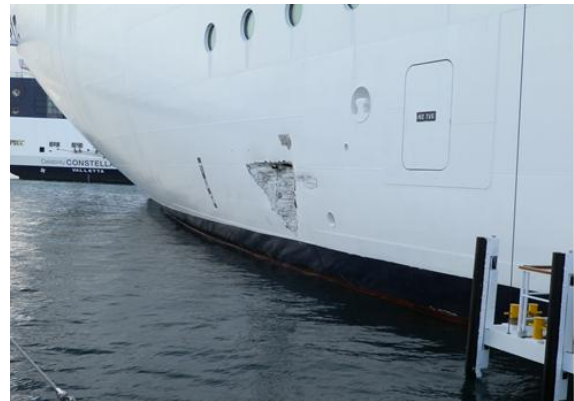
The cruise ship sustained a crack at the point of impact while her port underwater shell plating close to the waterline sustained deformations and intends lengthwise due the contact with the breakwater under the sea level. Her port stern quarter sustained an indent caused by port tug stem post during maneuvering to assist her.

1. Existing weather conditions and wind force effect on vessel's windage area were not taken under consideration prior to the commencement of the arrival procedures and entry into port passage as a factor to be assessed for a safe operation.
2. The risk assessment process conducted had not identified any specific risks in relation to weather

Figure 3: *The damaged port bow section of MSC Magnifica*

Supplement fleet's Safety Management System accordingly, highlighting the importance of weather conditions and wind effect during the entry into port procedures.

Weather conditions and wind effect on vessels' windage areas during the entry into port operations should be evaluated and processed
