SAFETY RECOMMENDATION No: 57/2013

09/2013: Impact of MSC Magnifica on Piraeus Port entrance breakwater.

Type of vessel: Passenger cruise vessel
Year of built: 2010

Impact of MSC Magnifica on Piraeus Port entrance breakwater

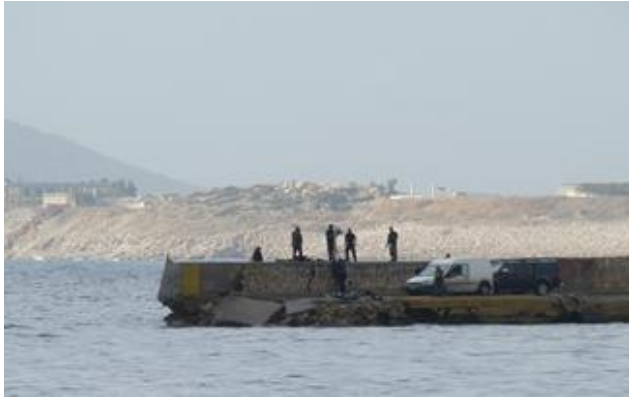
At approximately two minutes after pilot's embarkation the port bow of the cruise ship impacted on the head of the breakwater and the concrete round-hut red light, located on it, was detached and collapsed into the sea.

1. structural damages :
 - crack on port bow section above the waterline
 - deformation and intends and scratches on port side shell plating lengthwise under the waterline
 - indent at port aft quarter close to stern post
2. Piraeus' port entrance breakwater
 - Port entrance breakwater's head damaged
 - concrete round-hut red light detached and collapsed into the sea

Figure 2: *The damaged head of the breakwater.*

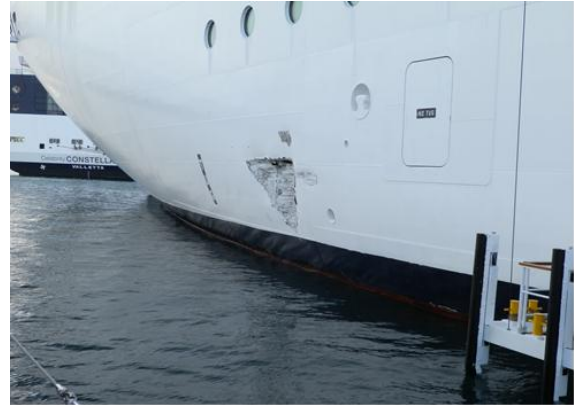
The cruise ship sustained a crack at the point of impact while her port underwater shell plating close to the waterline sustained deformations and intends lengthwise due the contact with the breakwater under the sea level. Her port stern quarter sustained an indent caused by port tug stem post during maneuvering to assist her.

Figure 3: *The damaged port bow section of MSC Magnifica*

Repairs were carried out while in berth by a marine service company and following her Class inspection, she departed from the port at morning hours on the next day of her arrival and continued her planned cruise voyage.
