SAFETY RECOMMENDATION No: 57/2014

07/2014: **FATAL FALL OF BOSUN FROM THE DECK CRANE OF B/C «PANORIA»** Flag Greece IMO: 9480930

FATAL FALL OF BOSUN FROM THE DECK CRANE OF B/C «PANORIA»

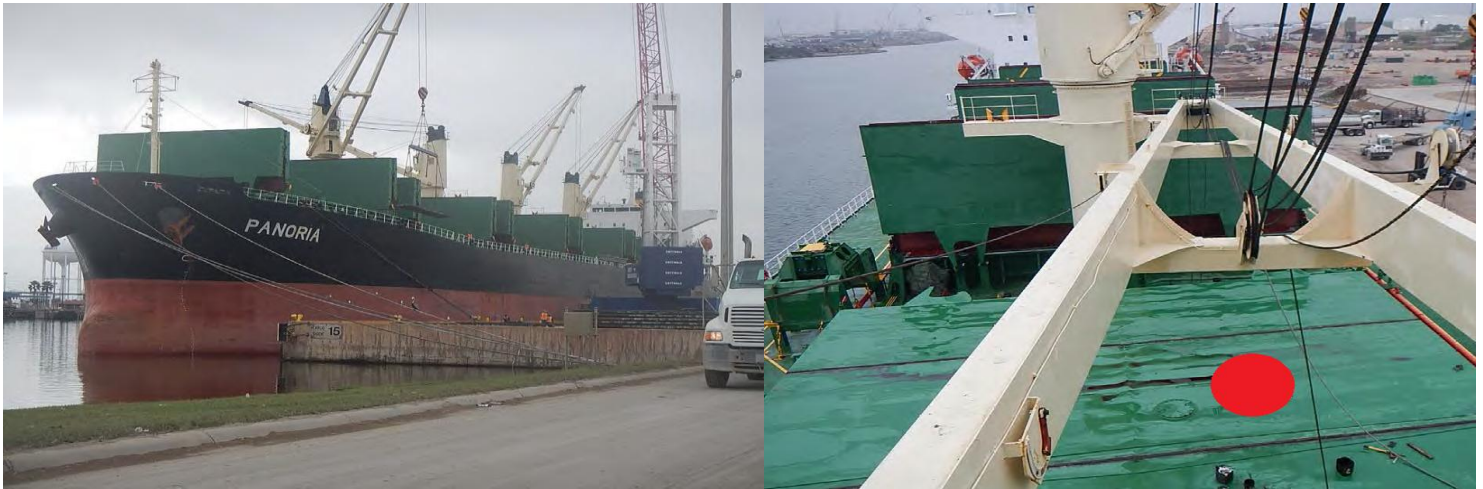
Vessel's berthing position at Brownsville, Texas, USA

The location where the Bosun fell on top of cargo hatch cover No.3
