SAFETY RECOMMENDATION No: 58/2014

07/2014: **FATAL FALL OF BOSUN FROM THE DECK CRANE OF B/C «PANORIA»** Flag Greece IMO: 9480930

INFORMATION OF ACCIDENT

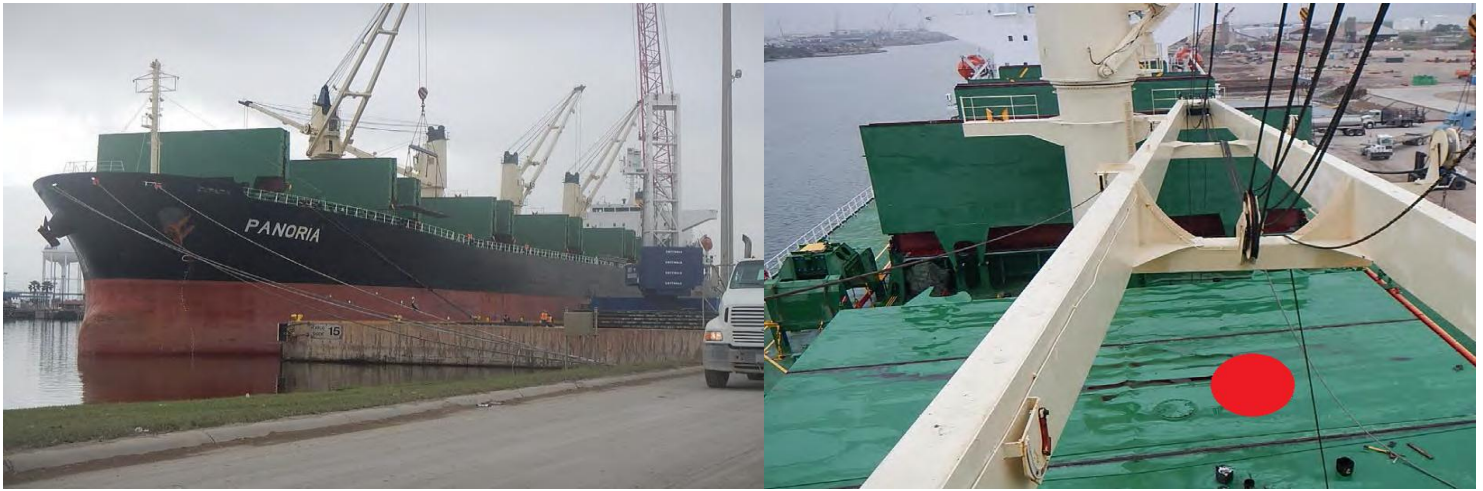
standing on the jib's cross section he lost his balance and fell from a height of 9.5 meters on the cargo hold's hatch cover. The safety harness did not prevent his fall as the old wire rope was not secured to any fixed point and was hanging free.

Vessel's berthing position at Brownsville, Texas, USA

The location where the Bosun fell on top of cargo hatch cover No.3
