SAFETY RECOMMENDATION No: 59/2013

09/2013: Impact of MSC Magnifica on Piraeus Port entrance breakwater.

Impact of MSC Magnifica on Piraeus Port entrance breakwater

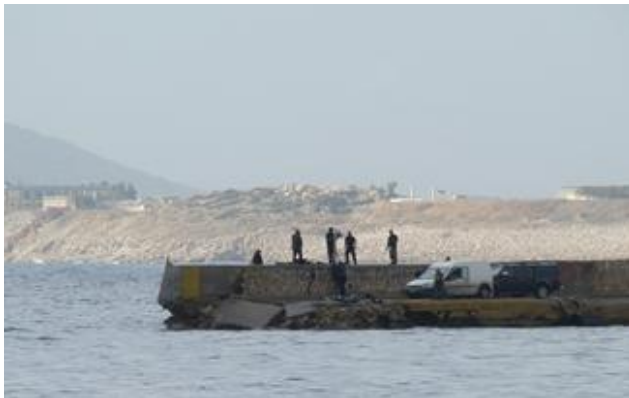
1. structural damages :
 - crack on port bow section above the waterline
 - deformation and intends and scratches on port side shell plating lengthwise under the waterline
 - indent at port aft quarter close to stern post
2. Piraeus' port entrance breakwater
 - Port entrance breakwater's head damaged
 - concrete round-hut red light detached and collapsed into the sea

Figure 2: *The damaged head of the breakwater.*

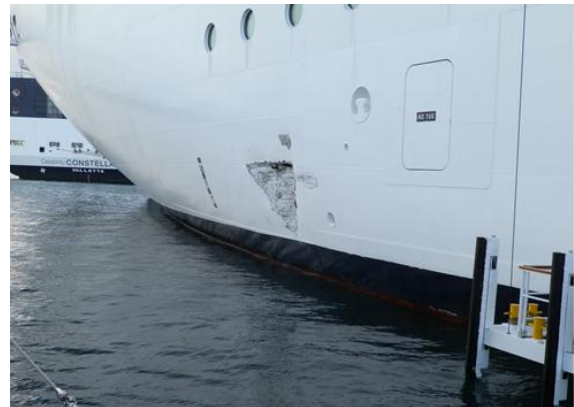
The cruise ship sustained a crack at the point of impact while her port underwater shell plating close to the waterline sustained deformations and intends lengthwise due the contact with the breakwater under the sea level. Her port stern quarter sustained an indent caused by port tug stem post during maneuvering to assist her.

Figure 3: *The damaged port bow section of MSC Magnifica*

Repairs were carried out while in berth by a marine service company and following her Class inspection, she departed from the port at morning hours on the next day of her arrival and continued her planned cruise voyage.
