SAFETY RECOMMENDATION No: 60/2014

08/2014: Grounding of C/V "YUSUF CEPNIOGLU"
(See the full Report [here.](#))

Grounding of C/V "YUSUF CEPNIOGLU"

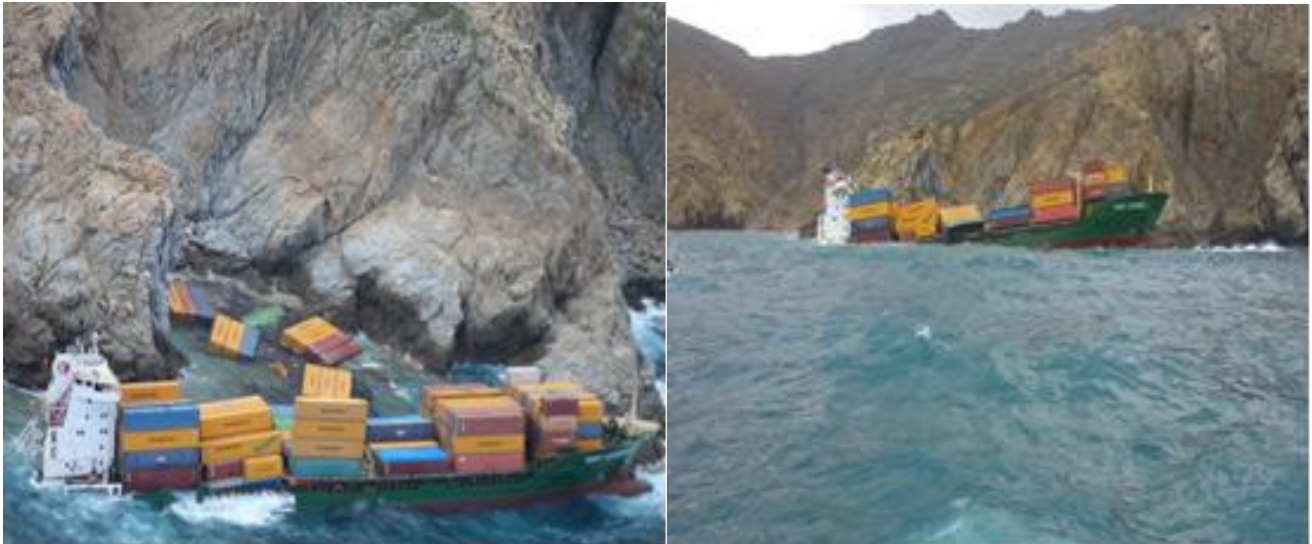
Grounding point of Yusuf Cepnioglu at Mykonos Island.

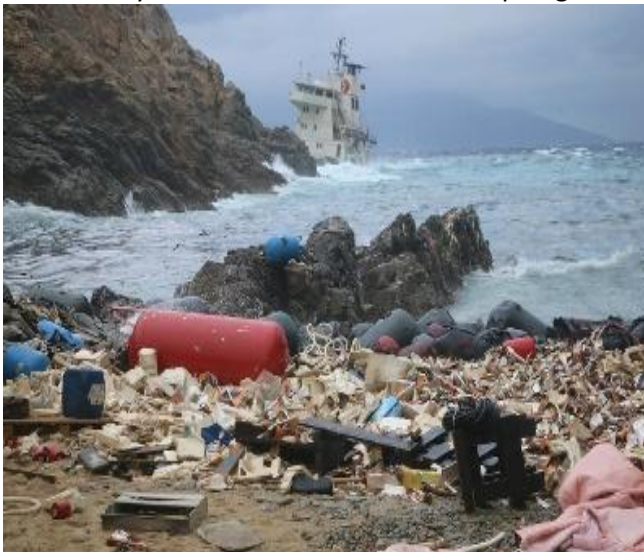
The hull of the vessel suffered multiple cracks and deformations on her bow and port side and several compartments including engine room, cargo holds and void spaces were flooded. Due to gale winds that prevailed on the same day several containers fell overboard. Pollution from vessel's bunkers as well as cargo from the containers was washed up to the shore. Salvage and clean up operations were commenced when permitted by weather conditions. Yusuf Cepnioglou was finally removed from the casualty area in two pieces.

Cargo debris washed up on the nearby coastline.

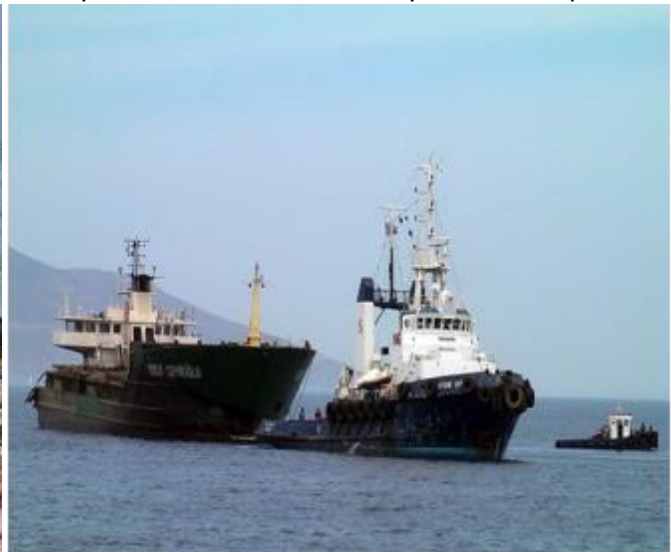
Yusuf Cepnioglu salvage operation
