SAFETY RECOMMENDATION No: 61/2013

09/2013: Impact of MSC Magnifica on Piraeus Port entrance breakwater.

Impact of MSC Magnifica on Piraeus Port entrance breakwater

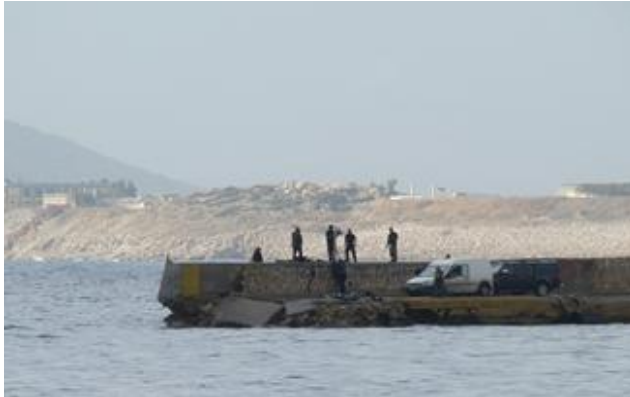
At approximately two minutes after pilot's embarkation the port bow of the cruise ship impacted on the head of the breakwater and the concrete round-hut red light, located on it, was detached and collapsed into the sea.

1. structural damages :
 - crack on port bow section above the waterline
 - deformation and indentations and scratches on port side shell plating lengthwise under the waterline
 - indent at port aft quarter close to stern post
2. Piraeus' port entrance breakwater
 - Port entrance breakwater's head damaged
 - concrete round-hut red light detached and collapsed into the sea

Figure 2: *The damaged head of the breakwater.*

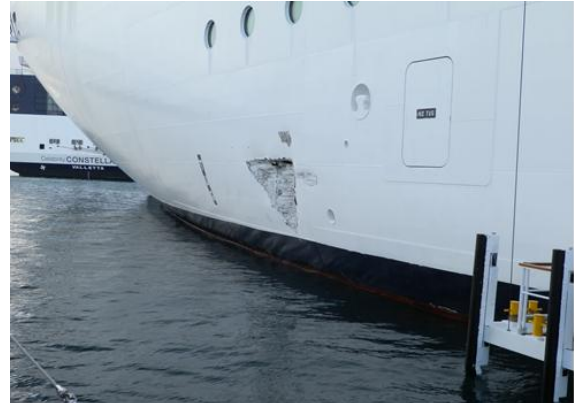
The cruise ship sustained a crack at the point of impact while her port underwater shell plating close to the waterline sustained deformations and indentations lengthwise due to the contact with the breakwater under the sea level. Her port stern quarter sustained an indentation caused by port tug stem post during maneuvering to assist her.

Shore up to date wind data was not requested by the Master.

Figure 3: *The damaged port bow section of MSC Magnifica*

Supplement existing procedures for pilotage by incorporating mandatory wind data information exchange with Masters of vessels calling at Piraeus port and within pilotage operation sea areas.

The Pilots should pass to Masters actual weather conditions of the sea areas to be navigated during the arrival procedures, regardless Master's requests.
