SAFETY RECOMMENDATION No: 61/2013

09/2013: Impact of MSC Magnifica on Piraeus Port entrance breakwater.

Impact of MSC Magnifica on Piraeus Port entrance breakwater

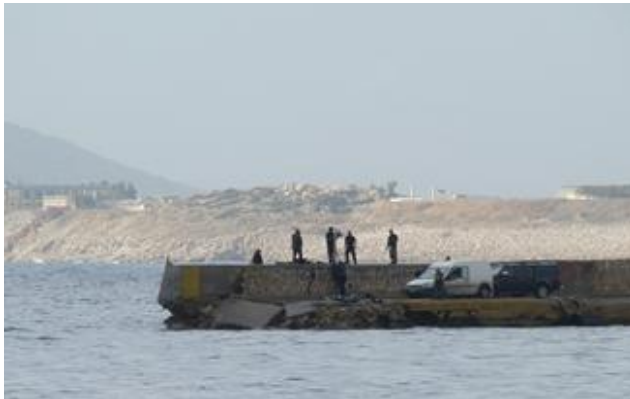
At approximately two minutes after pilot's embarkation the port bow of the cruise ship impacted on the head of the breakwater and the concrete round-hut red light, located on it, was detached and collapsed into the sea.

1. structural damages :
 - crack on port bow section above the waterline
 - deformation and intends and scratches on port side shell plating lengthwise under the waterline
 - indent at port aft quarter close to stern post
2. Piraeus' port entrance breakwater
 - Port entrance breakwater's head damaged
 - concrete round-hut red light detached and collapsed into the sea

Figure 2: *The damaged head of the breakwater.*

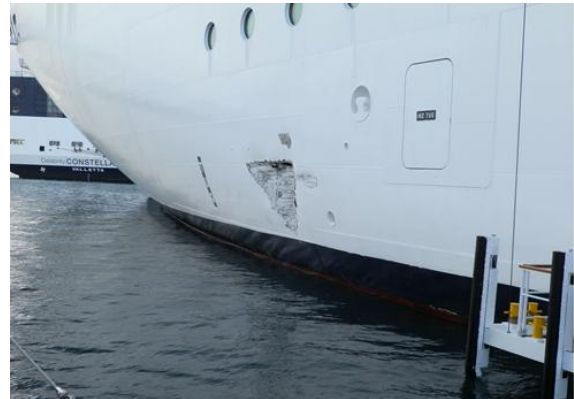
The cruise ship sustained a crack at the point of impact while her port underwater shell plating close to the waterline sustained deformations and intends lengthwise due the contact with the breakwater under the sea level. Her port stern quarter sustained an intend caused by port tug stem post during maneuvering to assist her.

Figure 3: *The damaged port bow section of MSC Magnifica*

Repairs were carried out while in berth by a marine service company and following her Class inspection, she departed from the port at morning hours on the next day of her arrival and continued her planned cruise voyage.
