SAFETY RECOMMENDATION No: 62/2013

09/2013: Impact of MSC Magnifica on Piraeus Port entrance breakwater.

Impact of MSC Magnifica on Piraeus Port entrance breakwater

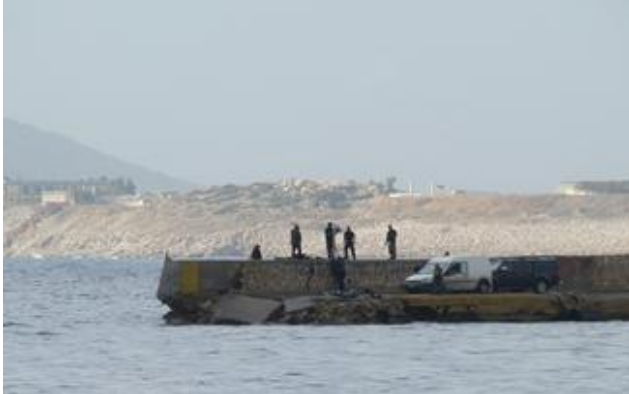
At approximately two minutes after pilot's embarkation the port bow of the cruise ship impacted on the head of the breakwater and the concrete round-hut red light, located on it, was detached and collapsed into the sea.

1. structural damages :
 - crack on port bow section above the waterline
 - deformation and intends and scratches on port side shell plating lengthwise under the waterline
 - indent at port aft quarter close to stern post
2. Piraeus' port entrance breakwater
 - Port entrance breakwater's head damaged
 - concrete round-hut red light detached and collapsed into the sea

Figure 2: *The damaged head of the breakwater.*

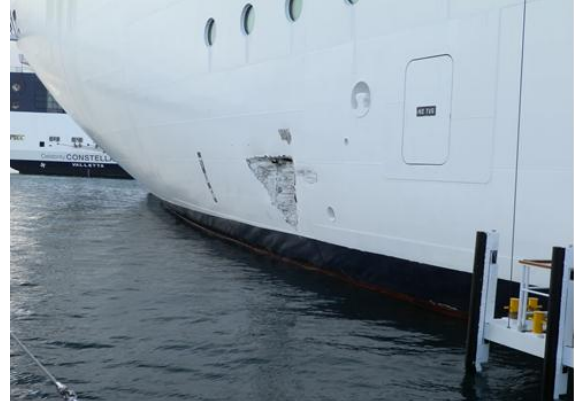
The cruise ship sustained a crack at the point of impact while her port underwater shell plating close to the waterline sustained deformations and intends lengthwise due the contact with the breakwater under the sea level. Her port stern quarter sustained an indent caused by port tug stem post during maneuvering to assist her.

Figure 3: *The damaged port bow section of MSC Magnifica*

Repairs were carried out while in berth by a marine service company and following her Class inspection, she departed from the port at morning hours on the next day of her arrival and continued her planned cruise voyage.
