SAFETY RECOMMENDATION No: 62/2015

62/2015: Entanglement of the towline used for towing C/V "HAMMERSMITH BRIDGE", flag Panama, IMO 9395147 resulting to the death of the Motorman of T/B "CHRISTOS XXII", Flag Greece, IMO 7230135

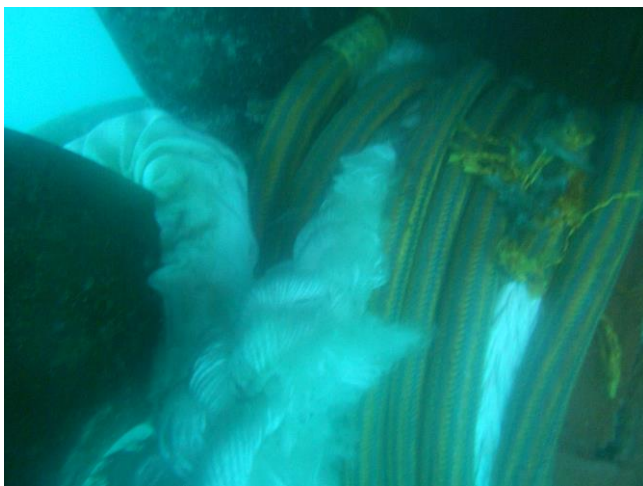
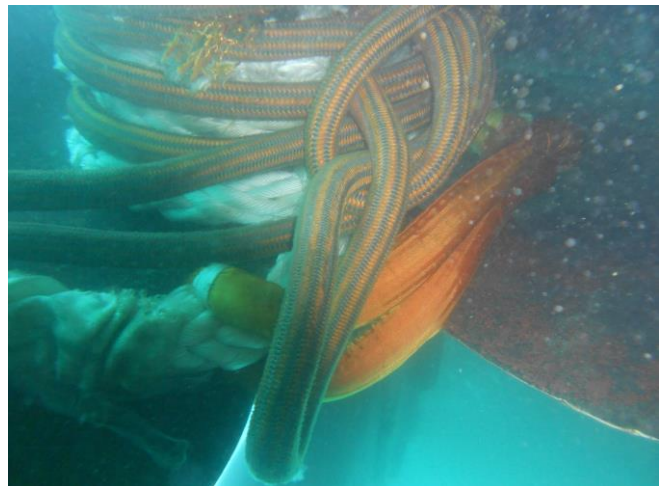
The Motorman, aged 43, suffered severe chest injuries, when the towline unexpectedly became taut and pinned him against the tugboat starboard bulwark. His heart and thoracic aorta were ruptured and both his lungs collapsed by the hit, resulting to his death.

Figures 2,3: captures of the entangled rope on the tug boat's stbd propeller.

Apply methods to their managed vessels, compatible with their structure, to prevent the towing line from moving onto the tug's side bulwarks during harbor operations.
