SAFETY RECOMMENDATION No: 64/2014

10/2014: Fire on board RoPax IERAPETRA L

Fire on board RoPax IERAPETRA L

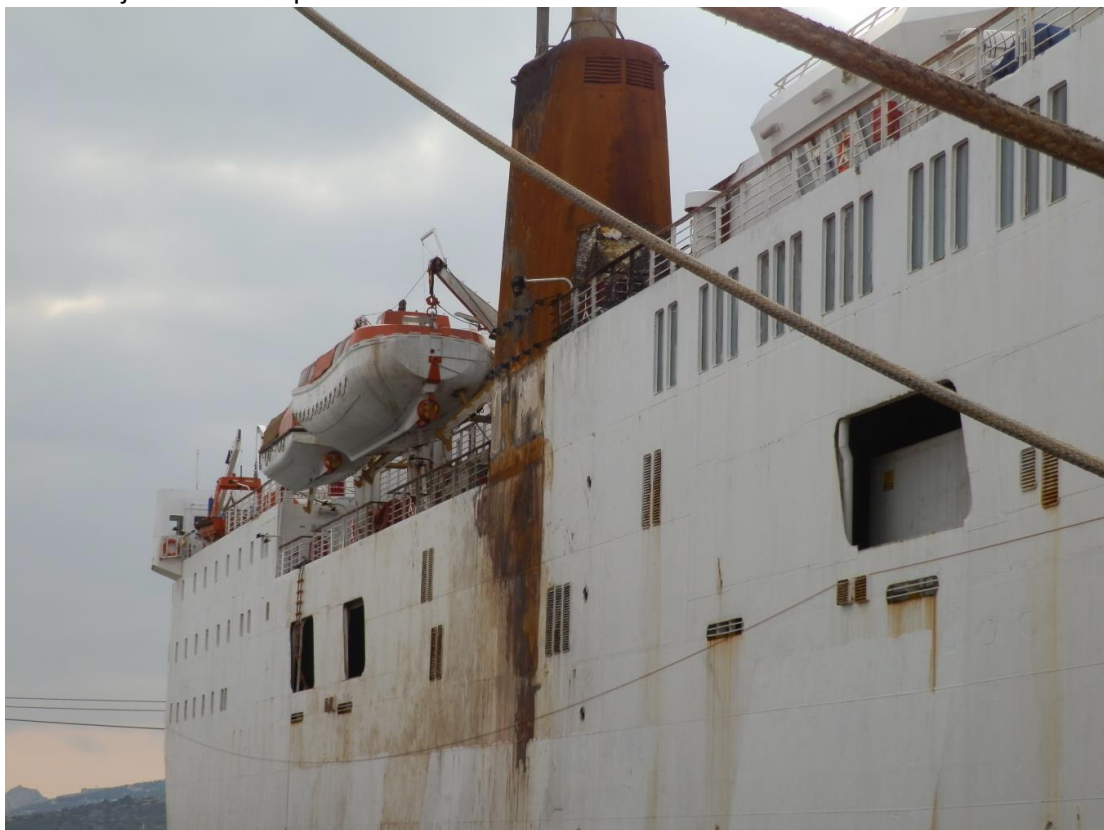
The fire caused extended damages to the inner side of the port side funnel and also to the adjacent to the port side funnels accommodation areas on decks No 7 and 8. No pollution and no injuries were reported.

Investigation identified that the main reasons contributing to the fire were related to the visual check and inspection, to make sure that all valves of the port main engine fuel oil return system were set and operated correctly, prior to the vessel's departure for Igoumenitsa, following the maintenance carried out. In particular the most possible cause for the fire breakout is the valve of the port side "return chamber", which was a small tank for the accumulation of fuel returns from the main engine's fuel supply system towards the recirculation to the fuel supply system, which had been damaged and found at closed position and this caused the fuel to overflow the tank and be led by its air extractor pipe

towards the interior of the port funnel duct, where it came in contact with hot surfaces of the main exhaust gas pipe.

Safety recommendations focused on the necessity for visual inspections and crosschecks following works carried out during maintenance (especially for setting the valves of the fuel supply systems), and the establishment of a safety arrangement like a level detector alarm, for dealing with possible overflow of all tanks that contain fuel and have air extractor pipes that end up within the funnel ducts of the vessel.
