SAFETY RECOMMENDATION No: 64/2015

64/2015: Entanglement of the towline used for towing C/V "HAMMERSMITH BRIDGE", flag Panama, IMO 9395147 resulting to the death of the Motorman of T/B "CHRISTOS XXII", Flag Greece, IMO 7230135

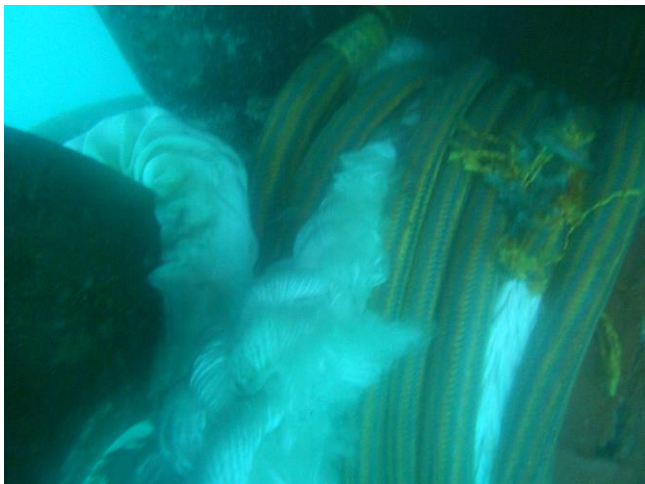
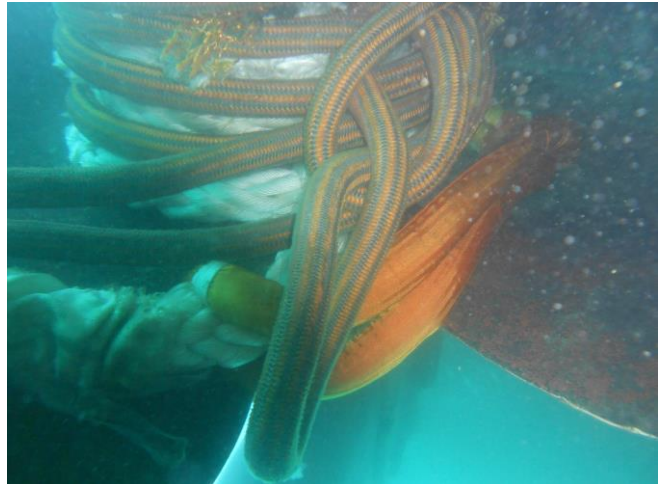
Figures 2,3: captures of the entangled rope on the tug boat's stbd propeller.
