SAFETY RECOMMENDATION No: 65/2014

10/2014: Fire on board RoPax IERAPETRA L

Fire on board RoPax IERAPETRA L

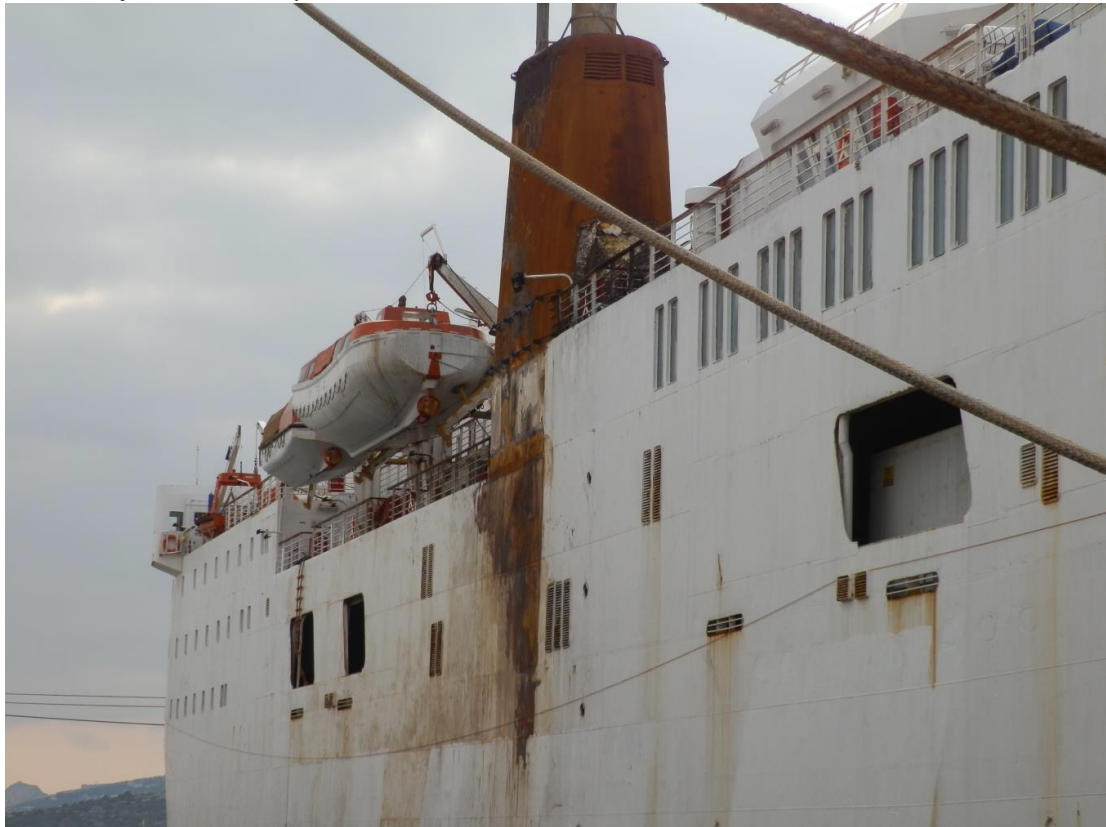
The fire caused extended damages to the inner side of the port side funnel and also to the adjacent to the port side funnels accommodation areas on decks No 7 and 8. No pollution and no injuries were reported.

Investigation identified that the main reasons contributing to the fire were related to the visual check and inspection, to make sure that all valves of the port main engine fuel oil return system were set and operated correctly, prior to the vessel's departure for Igoumenitsa, following the maintenance carried out. In particular the most possible cause for the fire breakout is the valve of the port side "return chamber", which was a small tank for the accumulation of fuel returns from the main engine's fuel supply system towards the recirculation to the fuel supply system, which had been damaged and found at closed position and this caused the fuel to overflow the tank and be led by its air extractor pipe towards the interior of the port funnel duct, where it came in contact with hot surfaces of the main exhaust gas pipe.

Safety recommendations focused on the necessity for visual inspections and crosschecks following works carried out during maintenance (especially for setting the valves of the fuel supply systems), and the establishment of a safety arrangement like a level detector alarm, for dealing with possible overflow of all tanks that contain fuel and have air extractor pipes that end up within the funnel ducts of the vessel.
