SAFETY RECOMMENDATION No: 65/2015

65/2015: Entanglement of the towline used for towing C/V "HAMMERSMITH BRIDGE", flag Panama, IMO 9395147 resulting to the death of the Motorman of T/B "CHRISTOS XXII", Flag Greece, IMO 7230135

The Owners / Managers of "HAMMERSMITH BRIDGE"

10/07/2016

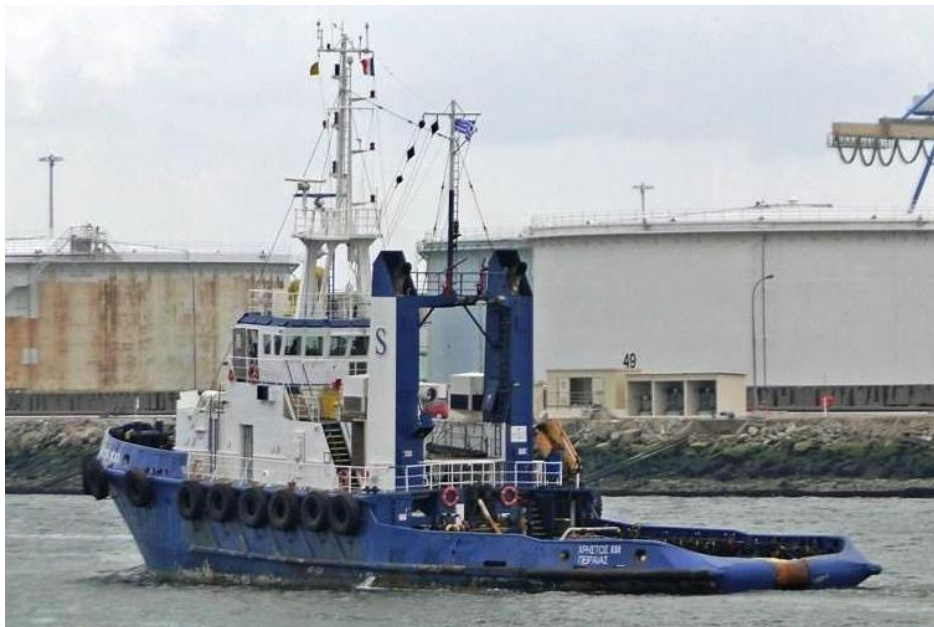
Figure 1: T/B CHRISTOS XXII.
