SAFETY RECOMMENDATION No: 66/2014

No of Safety Investigation Report:	10/2014: Fire on board RoPax IERAPETRA L (See the full Report here.)
Safety Recommendation addressed to:	The Ship's Control General Directorate of the Greek Administration through its Directorates
Date of publication:	22/11/2019

Fire on board RoPax IERAPETRA L

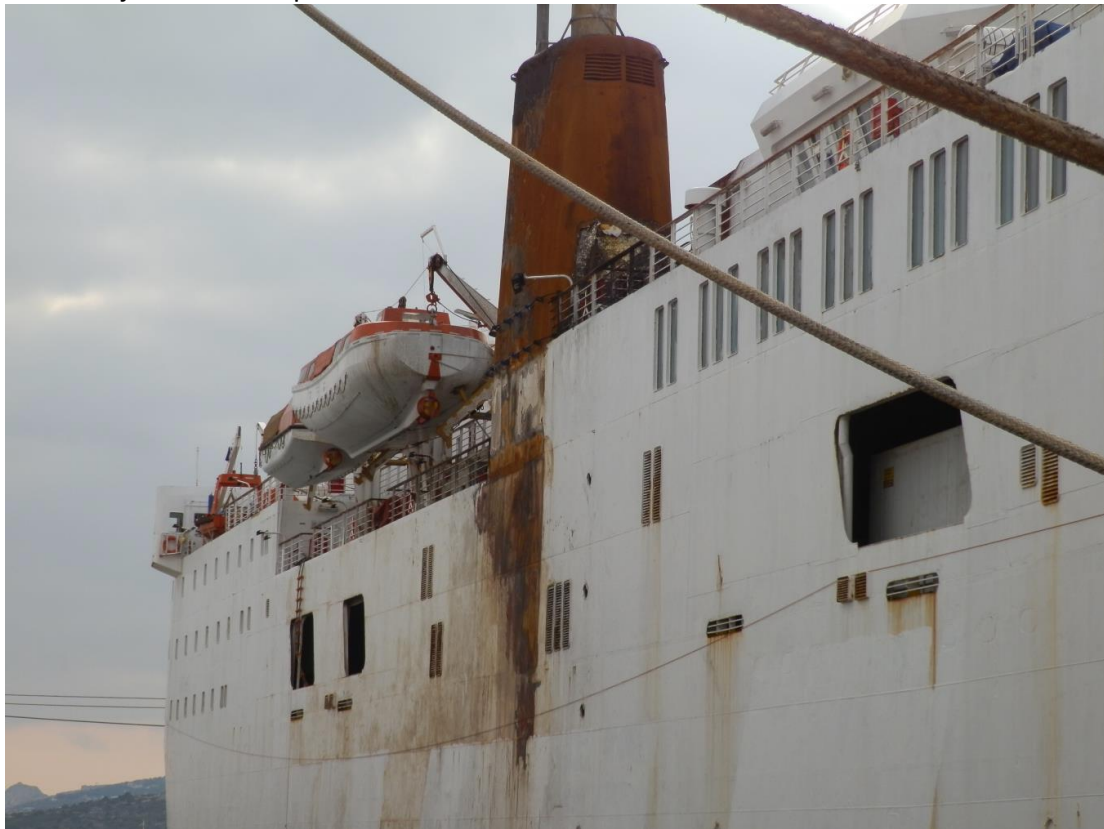
The fire caused extended damages to the inner side of the port side funnel and also to the adjacent to the port side funnels accommodation areas on decks No 7 and 8. No pollution and no injuries were reported.

Investigation identified that the main reasons contributing to the fire were related to the visual check and inspection, to make sure that all valves of the port main engine fuel oil return system were set and operated correctly, prior to the vessel's departure for Igoumenitsa, following the maintenance carried out. In particular the most possible cause for the fire breakout is the valve of the port side "return chamber", which was a small tank for the accumulation of fuel returns from the main engine's fuel supply system towards the recirculation to the fuel supply system, which had been damaged and found at closed position and this caused the fuel to overflow the tank and be led by its air extractor pipe towards the interior of the port funnel duct, where it came in contact with hot surfaces of

the main exhaust gas pipe.

Safety recommendations focused on the necessity for visual inspections and crosschecks following works carried out during maintenance (especially for setting the valves of the fuel supply systems), and the establishment of a safety arrangement like a level detector alarm, for dealing with possible overflow of all tanks that contain fuel and have air extractor pipes that end up within the funnel ducts of the vessel.
