SAFETY RECOMMENDATION No: 66/2015

66/2015: Entanglement of the towline used for towing C/V "HAMMERSMITH BRIDGE", flag Panama, IMO 9395147 resulting to the death of the Motorman of T/B "CHRISTOS XXII", Flag Greece, IMO 7230135

The tugboat and salvage associations

10/07/2016

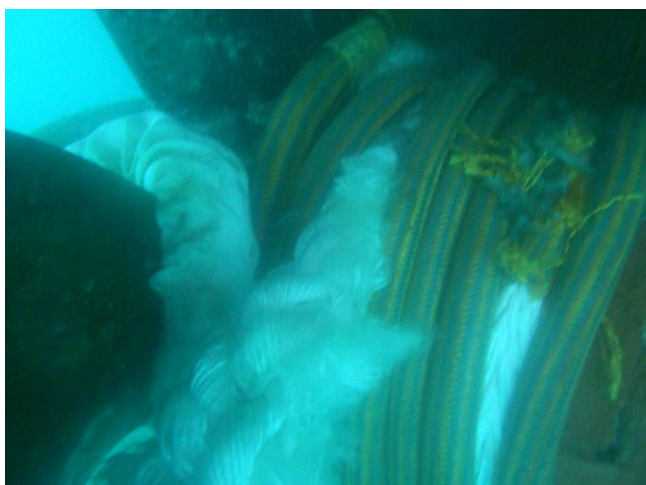
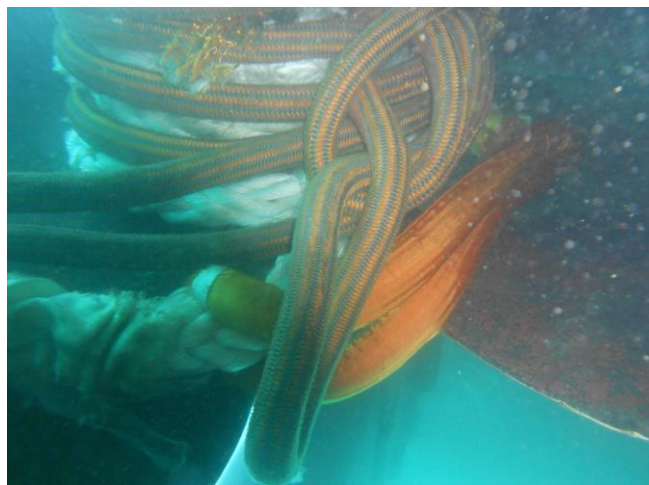
Figures 2,3: captures of the entangled rope on the tug boat's stbd propeller.
